## Merritt BCTS – Copper Creek Operating Area ME9362.02 Stream Assessment for TA0729 July 2020

BCTS requires reactivation and extension of ME9362.02, a branch of the Copper Creek FSR to access blocks in TA0729. This watershed has potential for tailed frog and all of the streams associated with this cutting permit are tributaries to Copper Creek (WSC 310-367800-78300) which is known to be fish bearing (Rainbow Trout). The two streams crossing ME9362.02 were assessed on July 24 2020 by Karen Grainger RPBio with BCTS staff Lee Williams RPF, David Lishman RPF and Campbell Burwash.

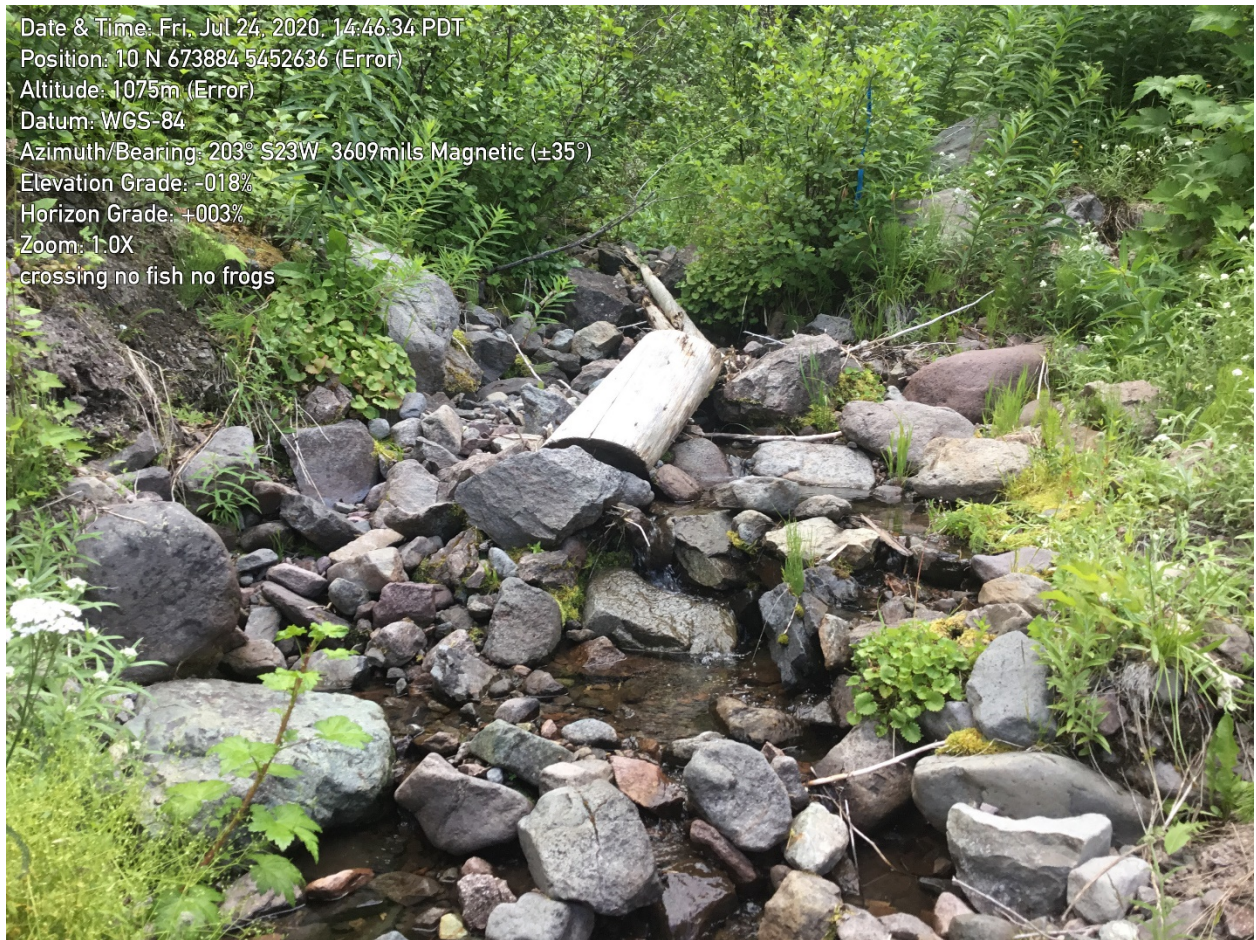
1. **Copper Creek tributary WSC 310-367800-78300-15100:** At the deactivated stream crossing (10U 673884 5452636) the stream has morphology appropriate for tailed frog (step pool morphology, cobble-dominated substrate) although it is suspected that this

stream may not provide perennial flows. A 30 minute time-constrained search of the reach at the crossing did not find any tailed frog tadpoles. Fish habitat is moderate but lack of deep pools for overwintering, and the probability that this stream dries up at times precludes it from providing perennial habitat. At the confluence with Copper Creek, the stream dissipates and goes underground with no channelized outlet preventing access for fish.

**Conclusion: this stream is not fish-bearing and is not tailed frog habitat.**

Photo 1. Deactivated crossing.

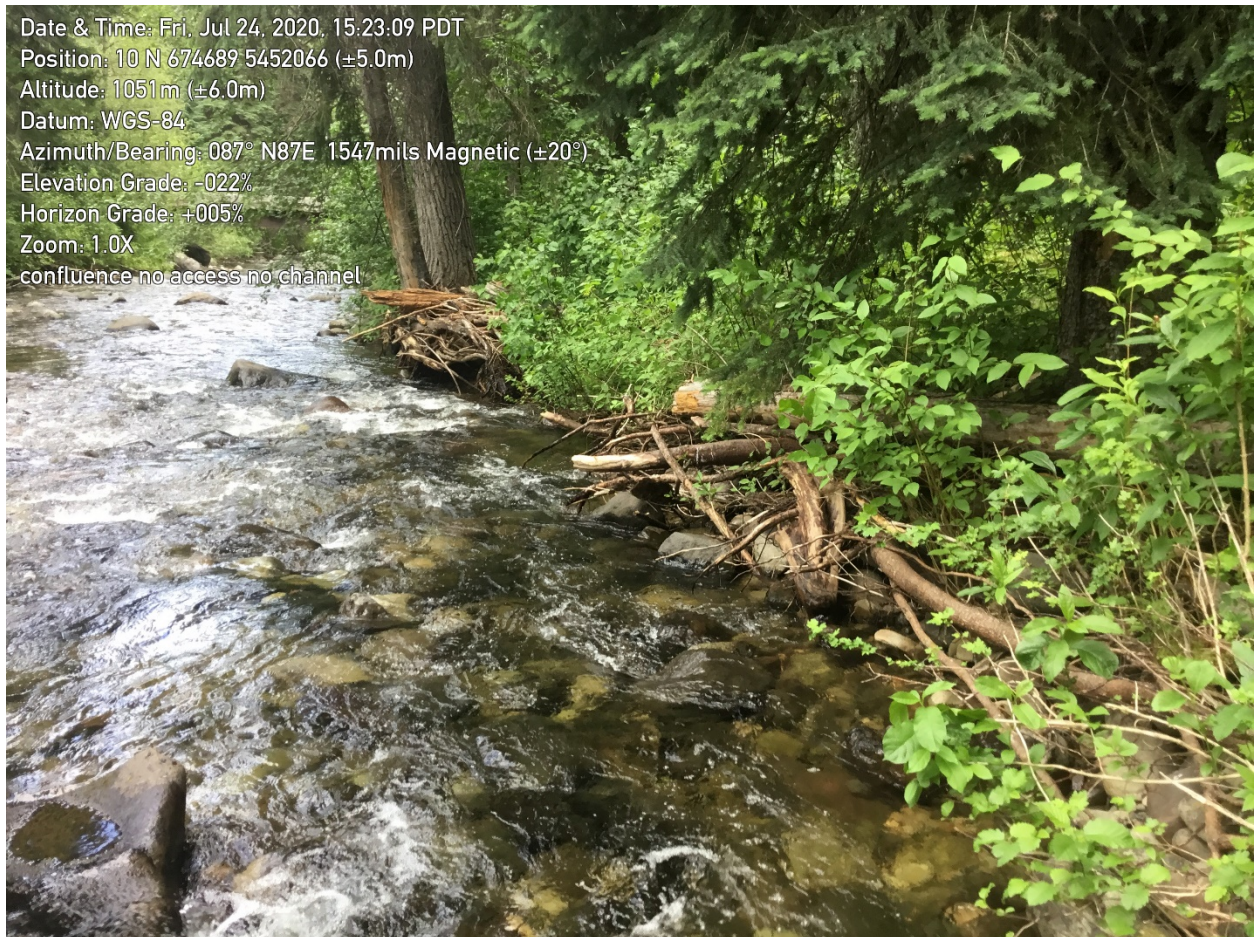
Photo 2. At the confluence with Copper Creek, the tributary has no channelized connection. The stream dissipates and goes underground before meeting Copper Creek.

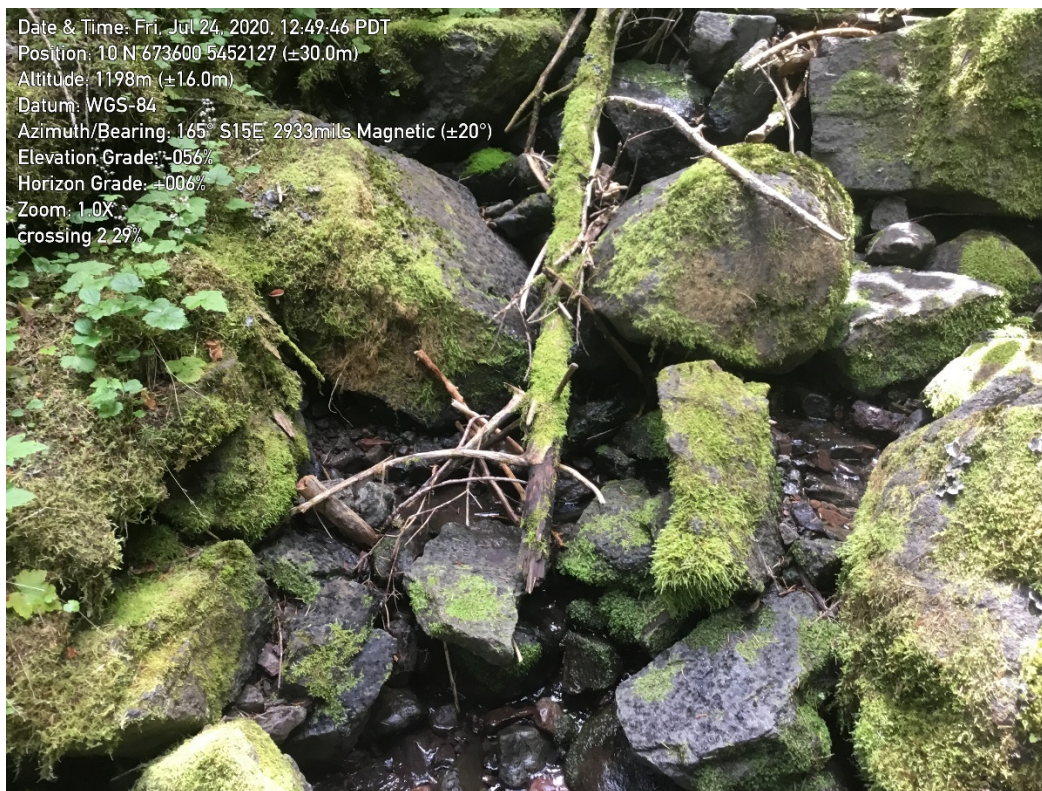
2. **Copper Creek tributary WSC 310-367800-78300-18900:** This small stream on the west boundary of CO9KS also appears to be seasonal. No tailed frog tadpoles were observed walking the length from the proposed crossing to the confluence with Copper Creek. There are several gradient barriers to fish passage (sections up to 37%) with no perennial fish habitat available. The stream dissipates and goes underground approximately 40m before meeting Copper Creek, with no channelized connection for fish passage.

**Conclusion: this stream is not fish-bearing and is not tailed frog habitat.**

Photo 3. In the area of the proposed crossing, the stream is small and steep (29%).

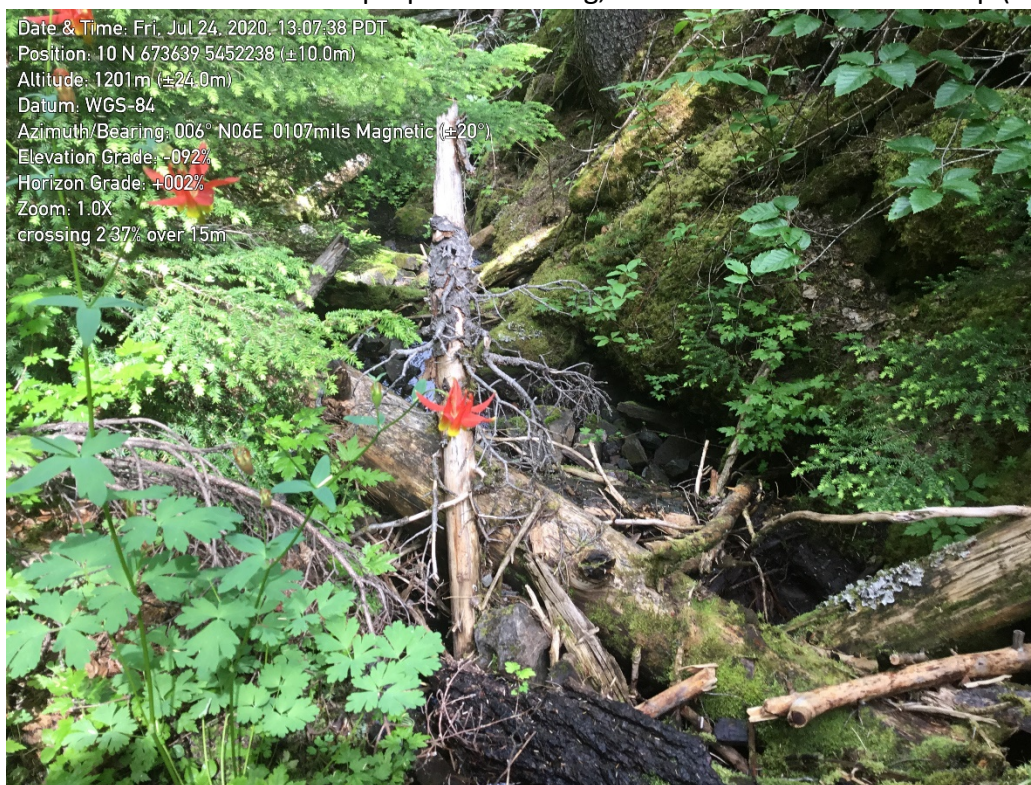
Photo 4. Lowest documented gradient barrier is 37% over 15m at 10U 673639 5452238.

Date & Time: Fri, Jul 24, 2020, 13:44:43 PDT  
Position: 10 N 673632 5452238 (Error)  
Altitude: 1198m (Error)  
Datum: WGS-84  
Azimuth/Bearing: 054° N54E 0960mils Magnetic ( $\pm 20^\circ$ )  
Elevation Grade: -015%  
Horizon Grade: +003%  
Zoom: 1.0X  
copper creek no outlet

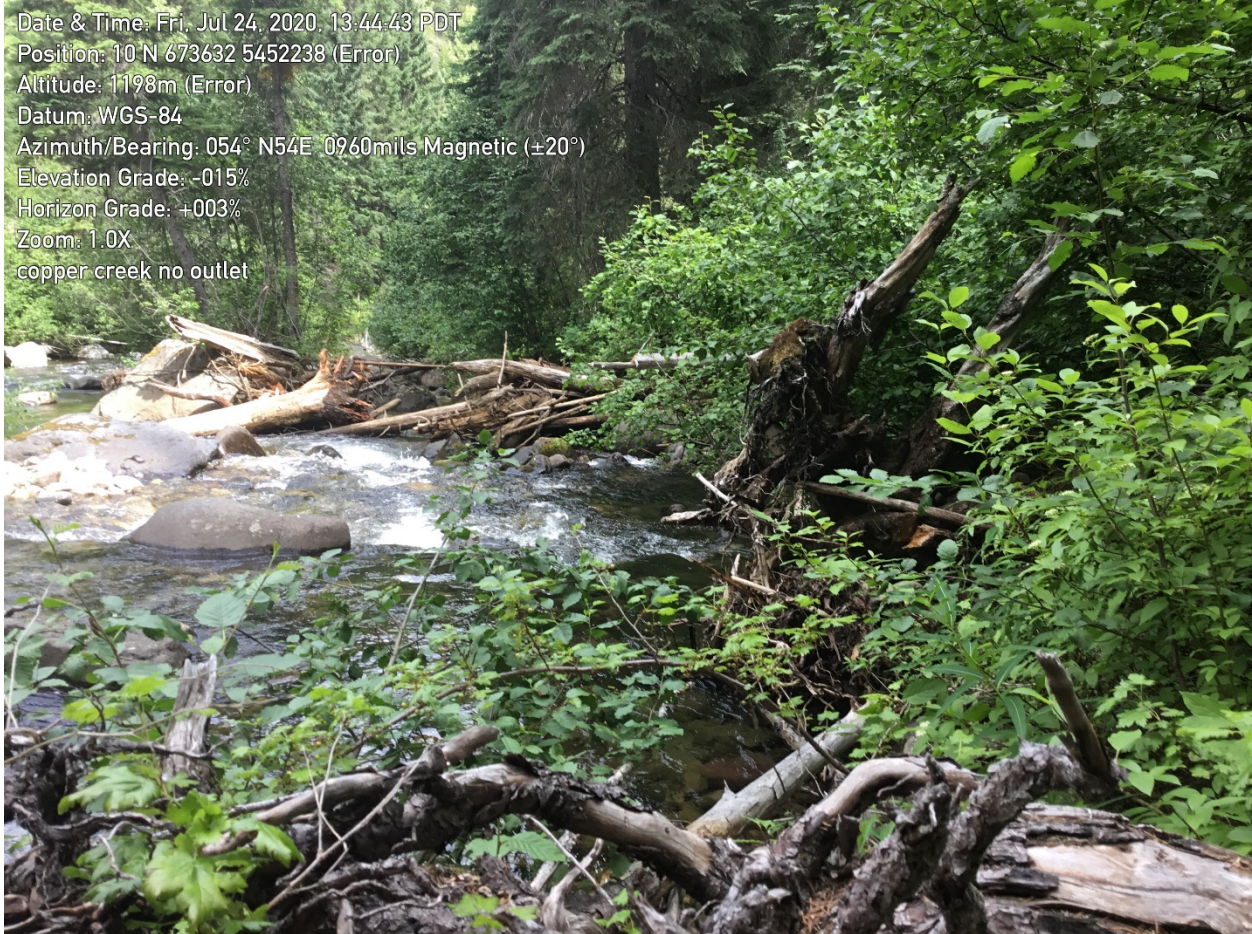
Photo 5. There is no channelized outlet at the confluence with Copper Creek and no potential for fish to access this stream.
