# **MARK CREEK HYDROLOGIC REVIEW**

**May 2021**

**BC Timber Sales  
East Kootenay Field Team  
Kootenay Business Area  
Forests, Lands, Natural Resource Operations and Rural Development**

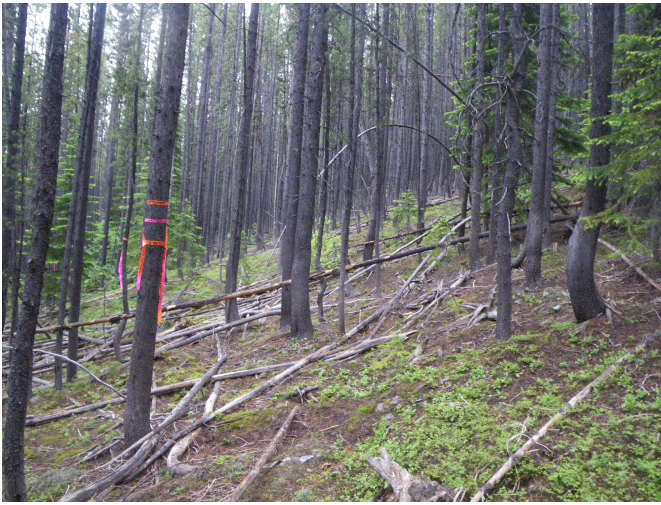
Based on preliminary layout boundaries flagged in the field, areas of proposed harvest and new road construction were inspected on Sullivan Hill (see Figure 1). The forest types in the area were dominated by mature pine, with some veteran larch and a mostly deciduous understory. Some juvenile fir, balsam, and spruce were also noted (Photo A).

Photo A – Mostly pine stand with little understorey and some juveniles of other species in G71-1376 (GPS 075).

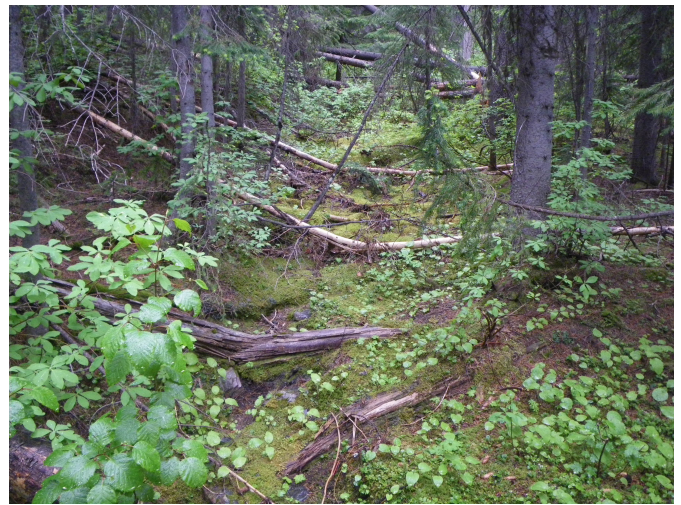
Photo B – A shallow draw with an intermittent channel. This is the mapped watercourse between proposed blocks G71-1376 and G71-1377 on Sullivan Hill (GPS 077).

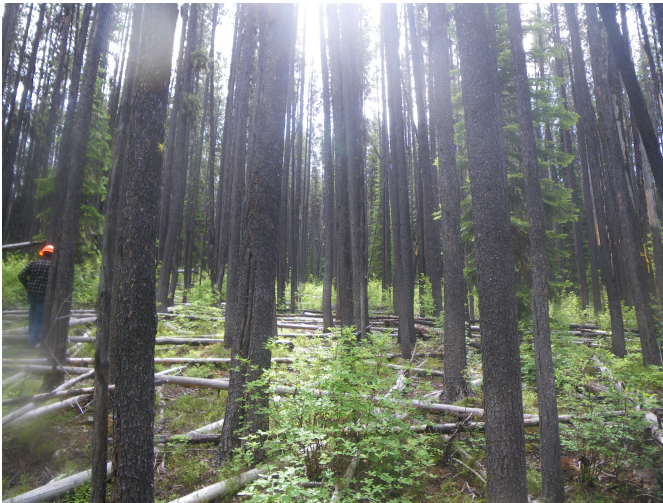
Photo C – Pure pine stand with low deciduous understorey in the southern portion of G71-1359 (GPS 092).

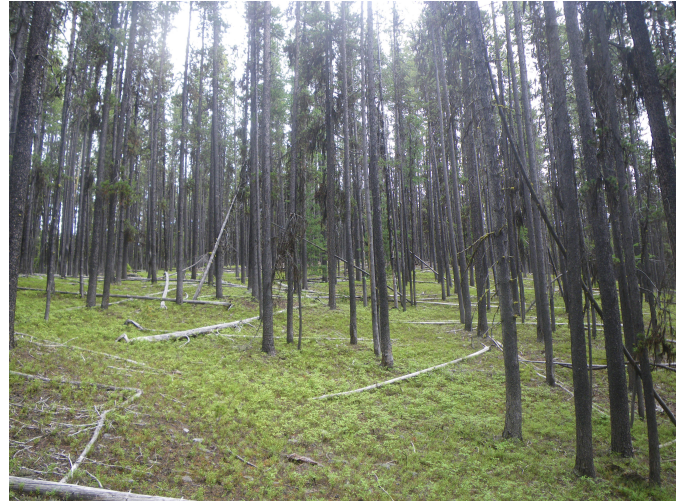
Photo D – Pure pine stand with little understorey in the northern portion of G71-1359 (GPS 094).

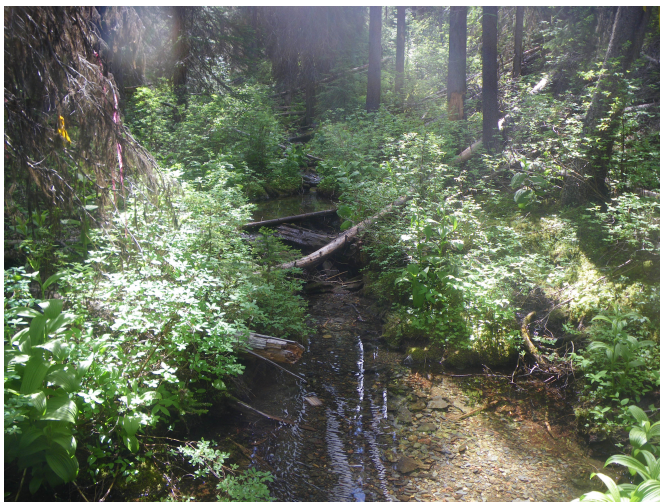
The mapped stream (S4) flowing through the middle of the proposed block was noted to be a flowing, gravel-bed riffle-pool stream with large woody debris inputs contributing to its morphology (Photo E). This suggests the preservation of riparian forests as currently planned is important to maintain channel stability. Although there are no fish present, a low impact crossing of this channel would require a bridge or a possibly large culvert (minimum 1800mm). It is also confined in a broad but steep-sided draw. After some discussion in the field, it was suggested that it may be easier to access the north half of the block from an existing old road to the north (Photo F), rather than trying to cross the creek and associated steep slopes. This would eliminate the need for a crossing on the creek, but require a longer access route, and reactivation of the old road (brushing and some upgrades). The ECA map was updated to reflect the access from either side (eliminating the need for a stream crossing).

Photo E – Stream channel through the middle of G71-1359. A Wildlife Tree Patch (WTP) is proposed as a riparian buffer (GPS 093).

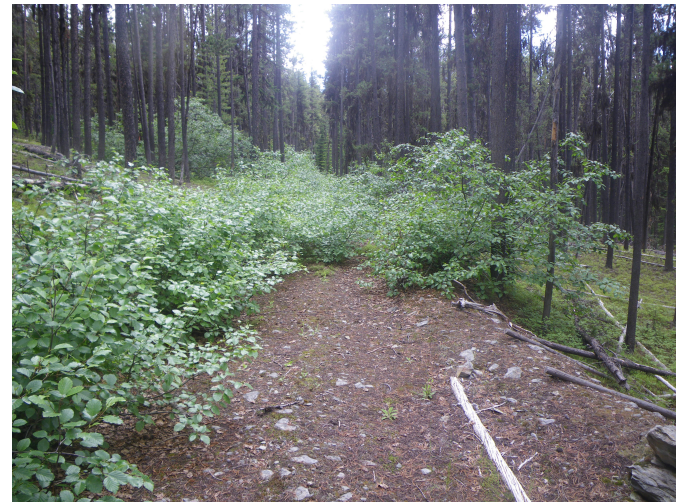
Photo F – Old road on the northern half of G71-1359 (GPS 094).

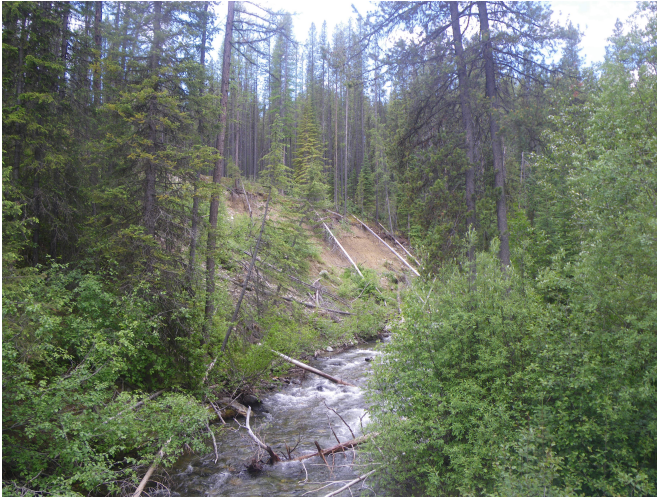
A previously identified slumping bank failure directly into Mark Creek just upstream of the second mainstem creek crossing was re-inspected. As noted in earlier assessments, erosion along the toe of the slope by the creek may have been the prime factor in the failure. The site may be a source of fine sediment (turbidity) into the creek during high water. This site has been assessed by a terrain stability professional and it was reported the failure was likely a natural occurrence.

Although there may be some continued raveling on the upper slope face since the last inspection, there were no new fallen trees. The toe (creek edge) appears to be mostly stable and 'greening-up' (Photo G). Despite minor seeps in the slope face, no dirty water appeared to be entering the creek at the time of inspection.

An existing (naturally eroding and raveling glaciofluvial terrace) bank failure has been identified as a chronic point source of sediment to the Mark Creek mainstem (Photo G). Field inspections suggest this bank failure area is recovering and currently producing minimal sediment. Continued monitoring of the site is recommended, especially following flood events.

Photo G – Natural, existing bank failure upstream of the second crossing of the Mark Creek mainstem (GPS 095). Note the green-up along the toe.

5. The natural bank/slope failure into Mark Creek above the second creek crossing appears to be recovering/revegetating. Continued monitoring of the site is recommended, especially following flood events.
