# **TERRAIN STABILITY ASSESSMENT**

**Rossiter 6500 FSR**

**Selkirk Forest District**

**Project No. 23-1816**

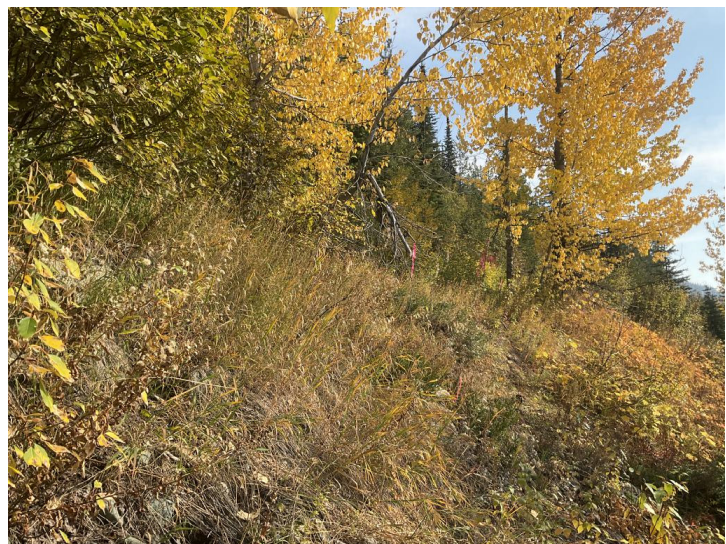
The surface configuration along the alignment is uniform with no significant drainage features (Photo 1). Slope gradients along the alignment are generally gentle to moderate (30% to 50%), with moderately steep (50% to 60%) gradient slopes from  $\Delta 8$  to  $\Delta 14$  and moderately steep to steep (50% to 75%) gradient slopes from  $\Delta 26$  to the POT. From the POC to  $\Delta 25$  the alignment is underlain by a moderately well to well drained till blanket (2.5 m to 4 m thick) comprised of a sandy silt with some gravel, trace boulders and cobbles, and a coarse fragment content (CFC) of 25%. From  $\Delta 25$

**Photo 1:** Typical uniform terrain along proposed Rossiter 6500 FSR.

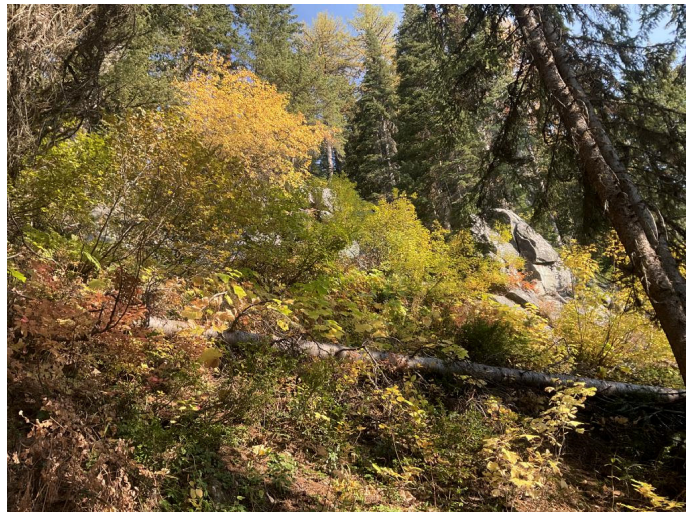
Slope gradients downslope of  $\Delta 25$  to the POT are generally moderately steep to steep (60% to 80%), with a short band of >80% bedrock bluffs (Photo 2). The band of bedrock bluffs are located approximately 10 m to 40 m downslope of the alignment, with the intervening distance increasing to the east. Surficial material in this area is comprised of the moderately well to well drained colluvial blanket observed along the alignment (refer to Section 4.1). The moderately steep to steep slopes continue downslope of the alignment for approximately 350 m.

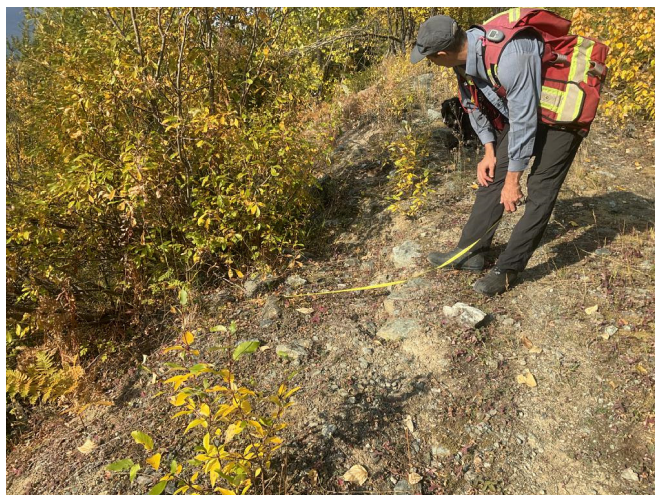
**Photo 3:** Minor fill settlement at 5.47 km on Rossiter FSR.

SCL has recommended culverts for drainage control along the assessed section of Rossiter FSR, including 1200 mm culverts at the Blaylock Creek crossings. It is recommended to construct a ditch where feasible, or in-slope the road 5% in areas where a ditch cannot be constructed. The road should be widened as necessary to gain the appropriate road width. Refer to the Prescription Summary table in Appendix C for more details on recommendations for the road upgrade.
