**BRITISH COLUMBIA  
ARCHAEOLOGICAL IMPACT ASSESSMENT  
INTERIM REPORT FORM**

2017-0169-020, AIA of BCTS Stuart Nechako block AIR16\_29

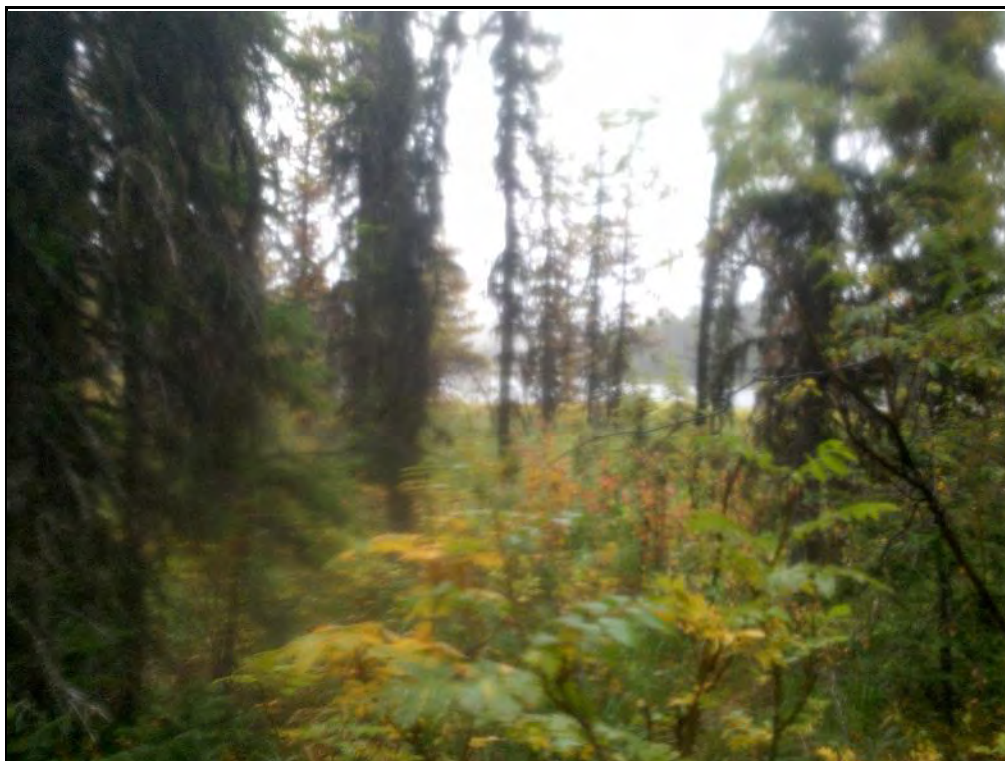
Lake A and Wetland A are surrounded by gently sloping terrain that is hummocky. There is a knoll on the northwest side of the lake that levels out at STL3. The vegetation around the lake consists of subalpine fir and spruce overstory, and an understory of horsetail, oak fern, five-leaved brambleberry, club moss, and bunchberry (Photo 1).

Photo 1. Lake A, view southeast.

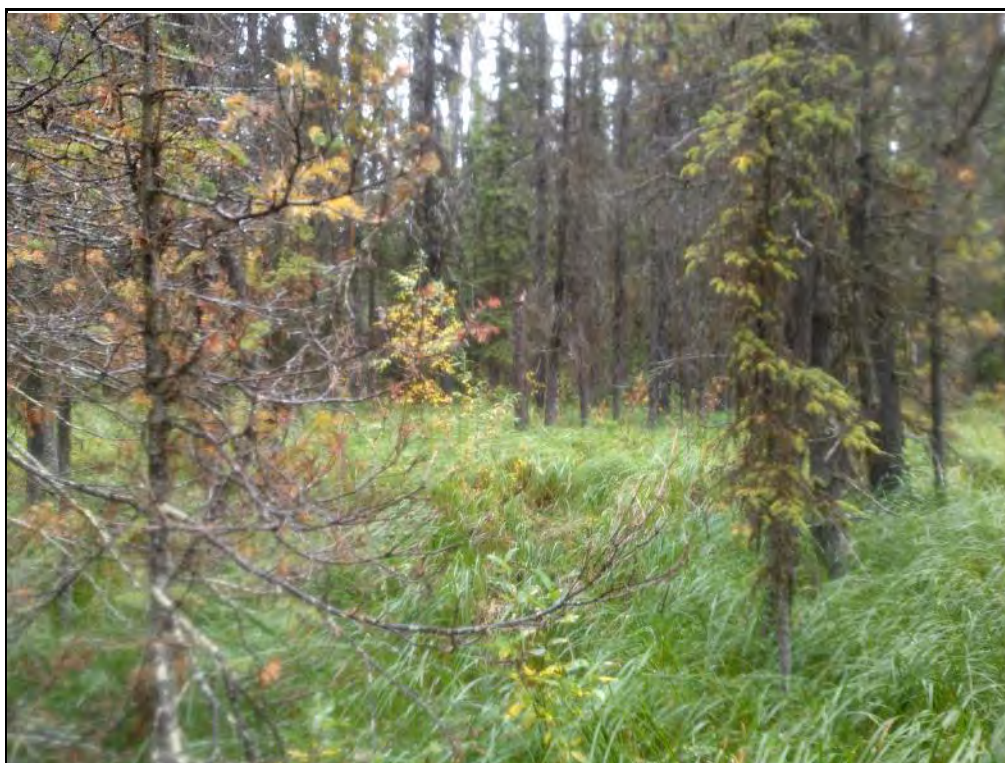
Stream D and Stream E are grassy marsh areas with large pools of standing water. The stream is surrounded by low lying terrain that slopes towards the stream with no breaks. There are two knolls adjacent the wetland that level out at STL1 and STL2 (Photo 2).

Photo 2. Stream D, view north.

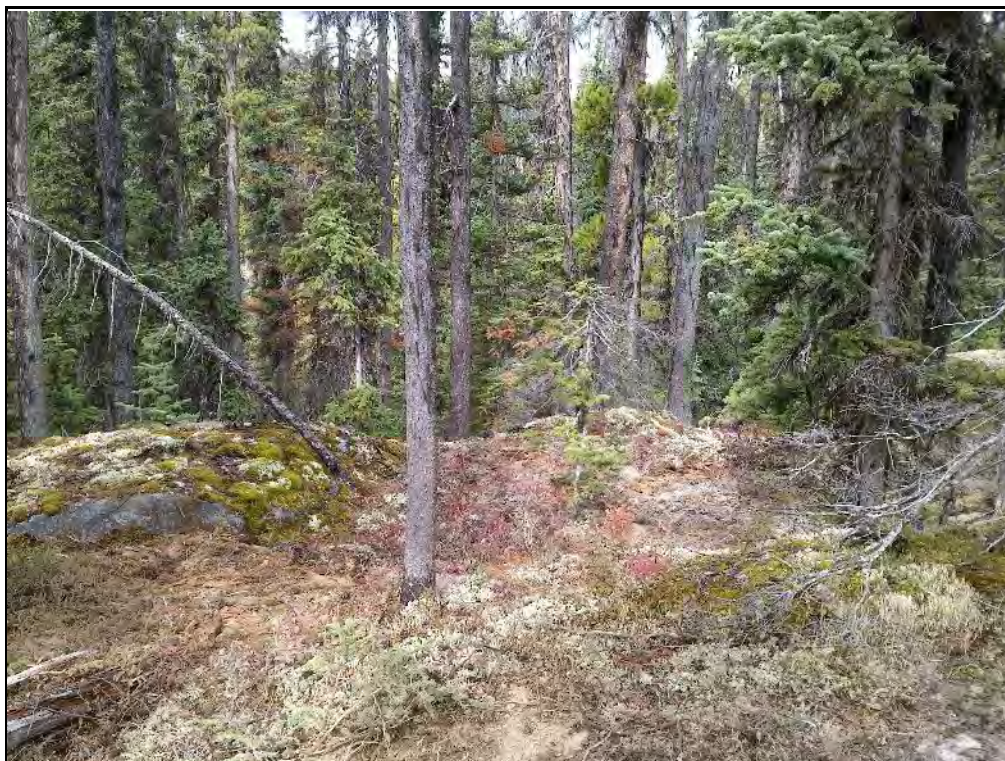
| Subsurface Test Area | Description | Dimensions (L x W) | Subsurface Tests | | |
|---|---|---|---|---|---|
| STL1 | Elongated knoll overlooking Wetland D and Stream D (Photo 3). | 6 x 6 m & 7 x 5 m | 15 | 0 | 15 |

Photo 3. STL1, view north.

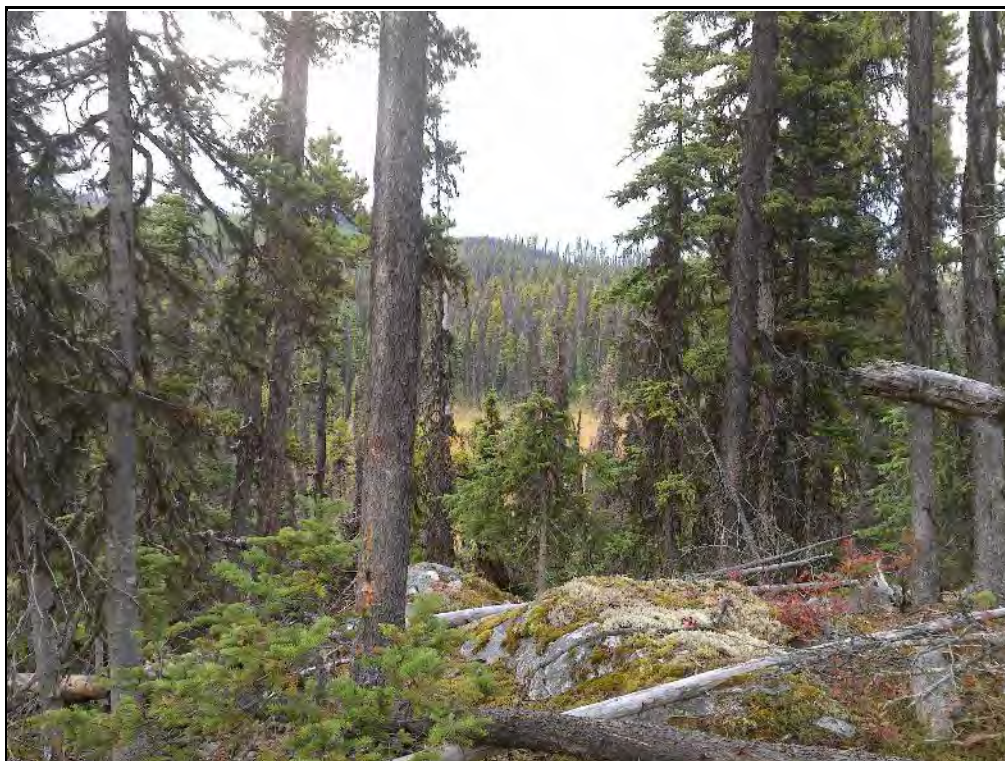
| Subsurface Test Area | Description | Dimensions (L x W) | Subsurface Tests | | |
|---|---|---|---|---|---|
| STL2 | Promontory overlooking Wetland B (Photo 4). | 12 x 9 m | 10 | 0 | 10 |

Photo 4. STL2, view north.

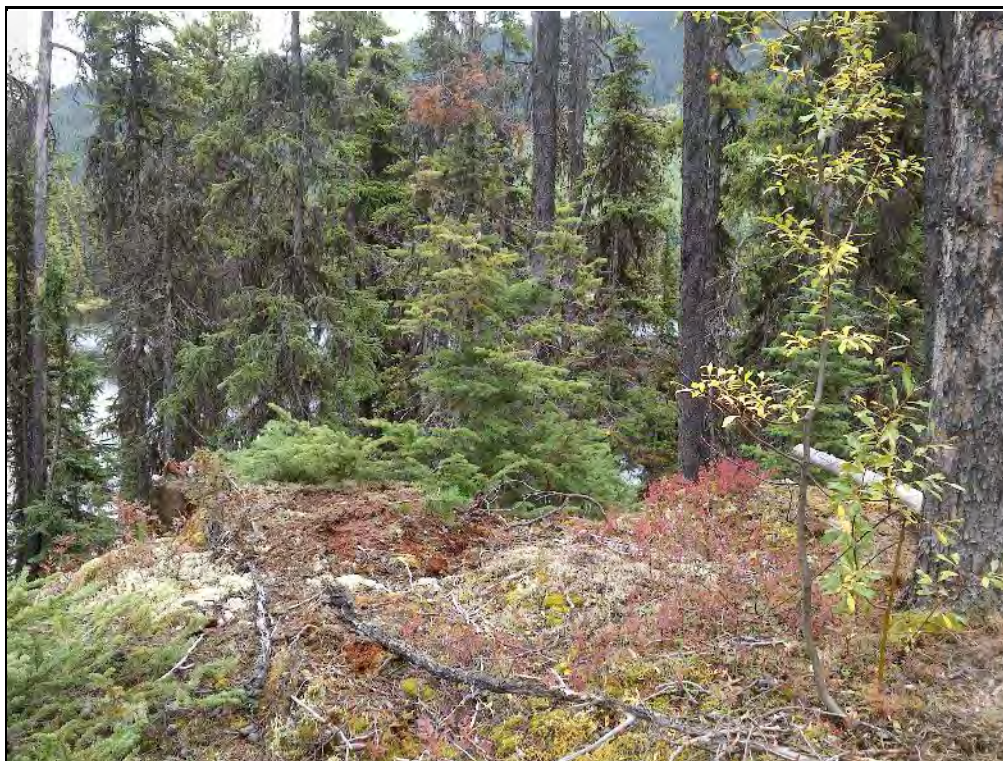
| Subsurface Test Area | Description | Dimensions (L x W) | Subsurface Tests | | |
|---|---|---|---|---|---|
| STL3 | Knoll overlooking Lake A (Photo 5). | 10 x 7 m | 13 | 0 | 13 |

Photo 5. STL3, view east.

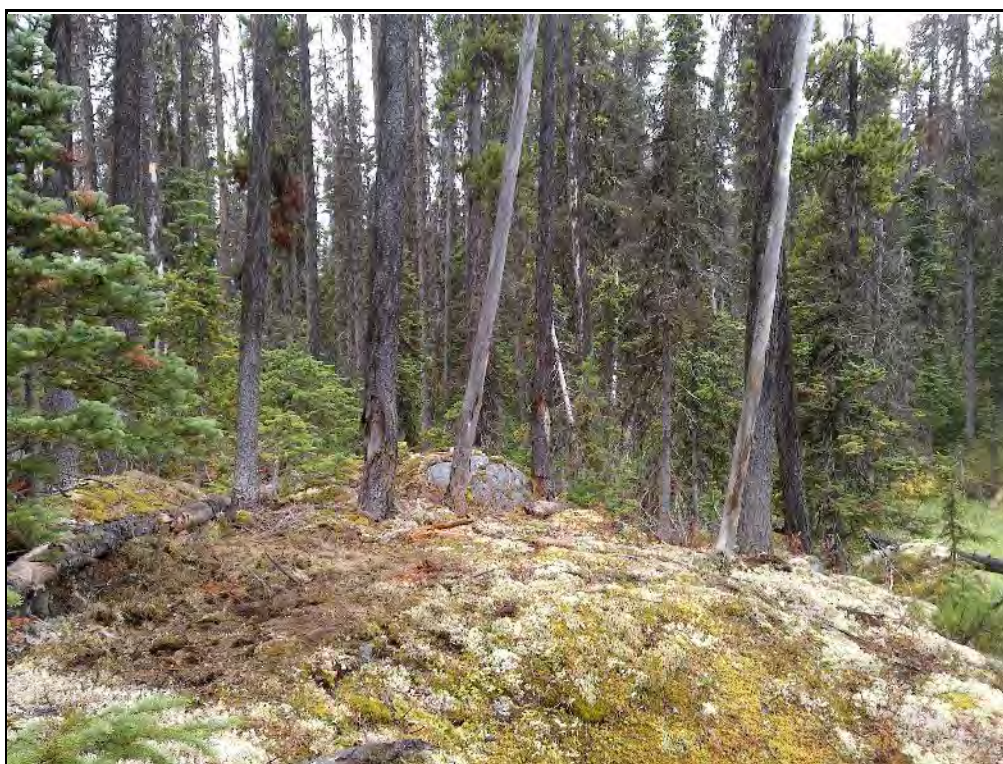
| Subsurface Test Area | Description | Dimensions (L x W) | Subsurface Tests | | |
|---|---|---|---|---|---|
| STL4 | Knoll overlooking Stream F (Photo 6). | 18 x 5 m | 8 | 0 | 8 |

Photo 6. STL4, view northwest.
