## Corporate Bridge Register (CBR) Structure Inventory Data Form "BRIDGES"

CK-2144

**Routine Condition Bridge Inspection Form**  
(except for log stringer or timber stringer bridges)

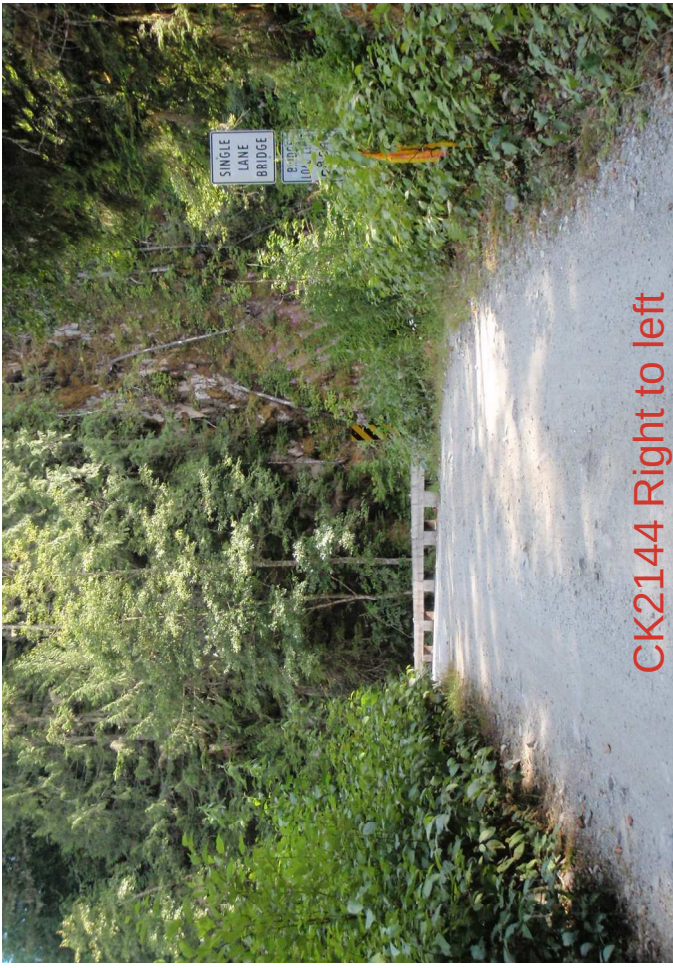
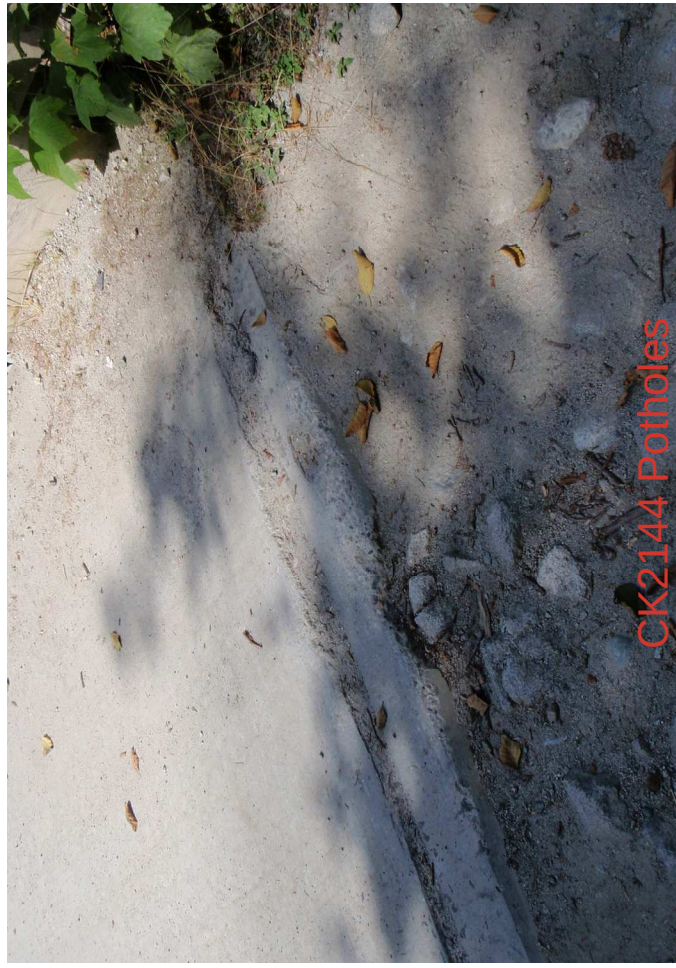
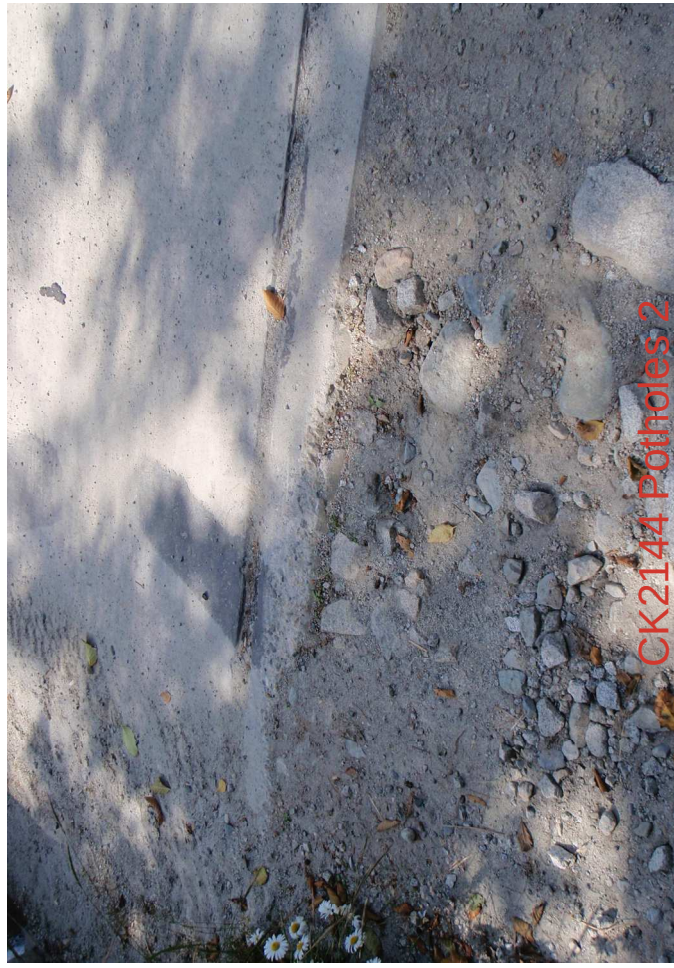
| GENERAL INFORMATION | | | | (enter either long/lat or UTM below -- not both) | | | |
|---|---|---|---|---|--|--|--|
| Ballast Wall | E G <u>(F)</u> P N/A UR | TOP OF BALLAST WALL DAMAGED DUE TO LARGE POTHOLES ON APPROACHES. THE RIGHT BALLAST WALL: RE BAR SHOWING | | | | | |
