## Corporate Bridge Register (CBR) Structure Inventory Data Form "BRIDGES"

| *Structure # <u>CK-2254</u> | *Site #: <u>CK-2254</u> |
| *Forest Service Road: <u>SQUEAH</u> | Kilometres: <u>6.1</u> |

**Routine Condition Bridge Inspection Form**  
(except for log stringer or timber stringer bridges)

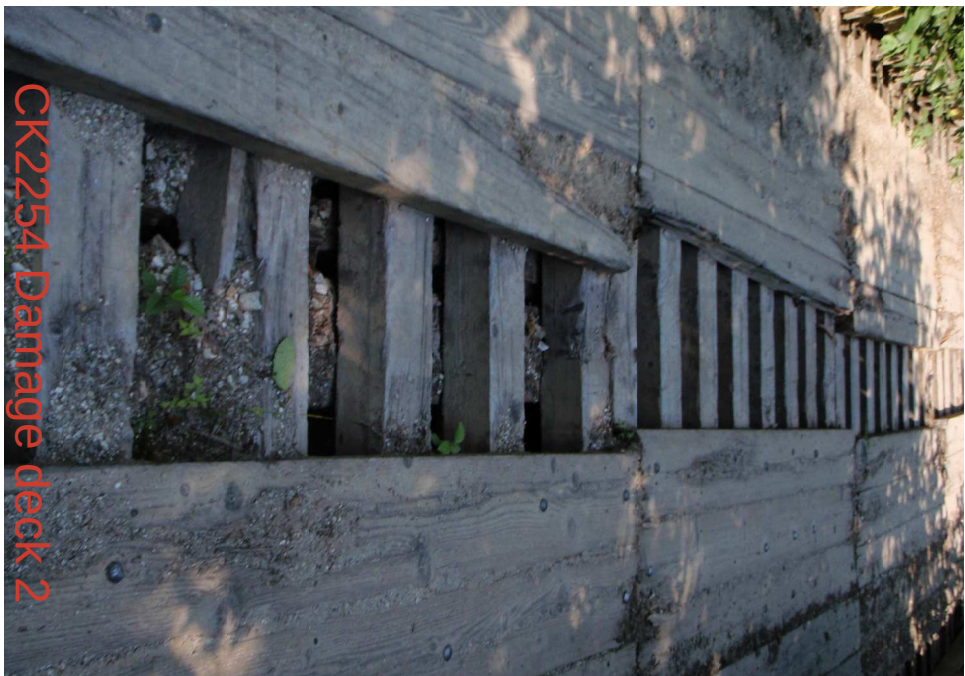
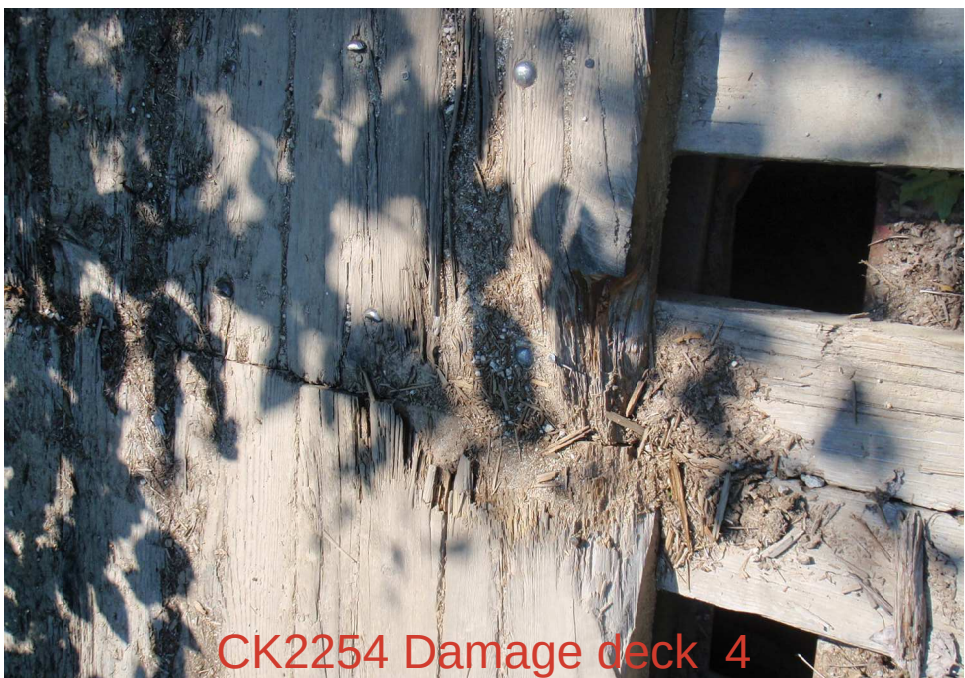
| GENERAL INFORMATION | | | | (enter either long/lat or UTM below – not both) | | | |
|---|---|---|---|---|--|--|--|
| Running Planks | E G <u>(F)</u> P N/A UR | SOME ROTTEN & BADLY DAMAGED. | | | | | |
| Overall Deck Condition | E G F <u>(P)</u> UR | | | | | | |

CK2254 Damage deck
