Corporate Bridge Register (CBR)  
Structure Inventory Data Form "BRIDGES"

| *Forest Service Road: 0710105 CRK | Kilometres: 30.8 |

CK2300

**Routine Condition Bridge Inspection Form**  
(except for log stringer or timber stringer bridges)

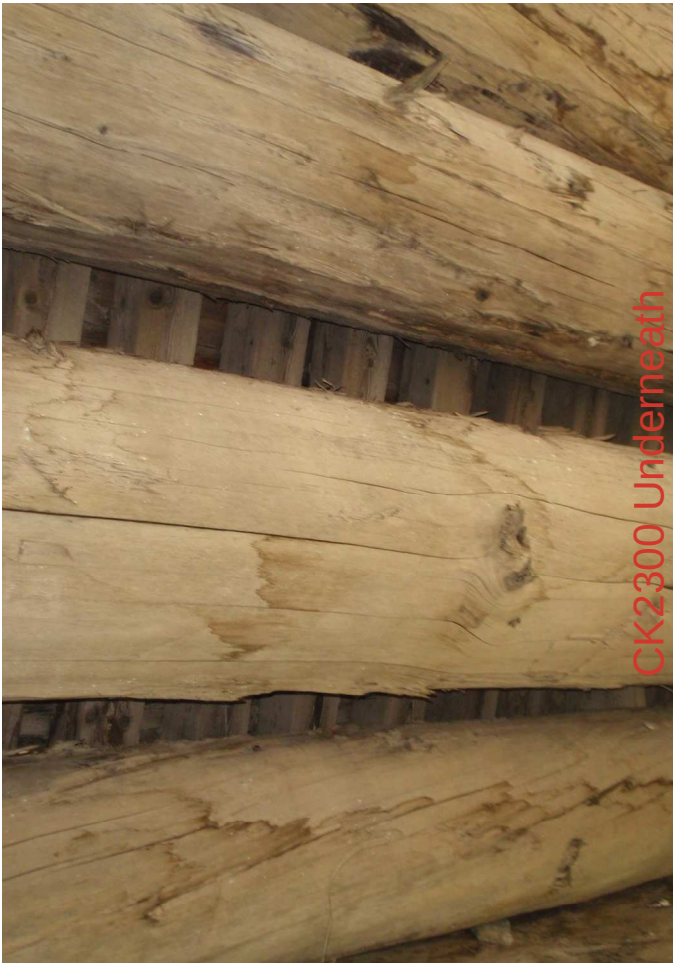
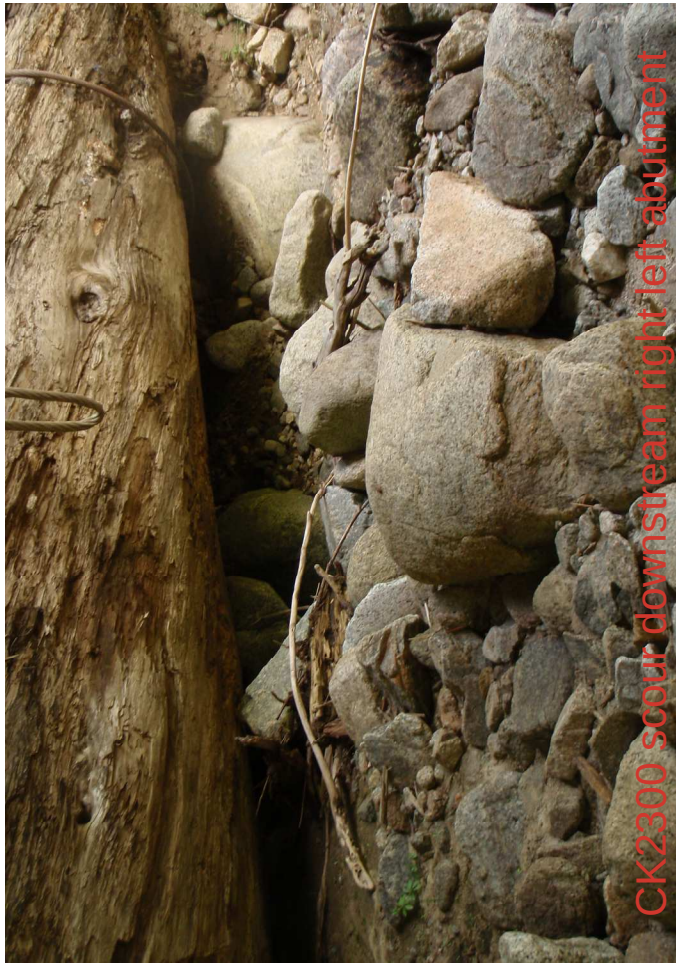
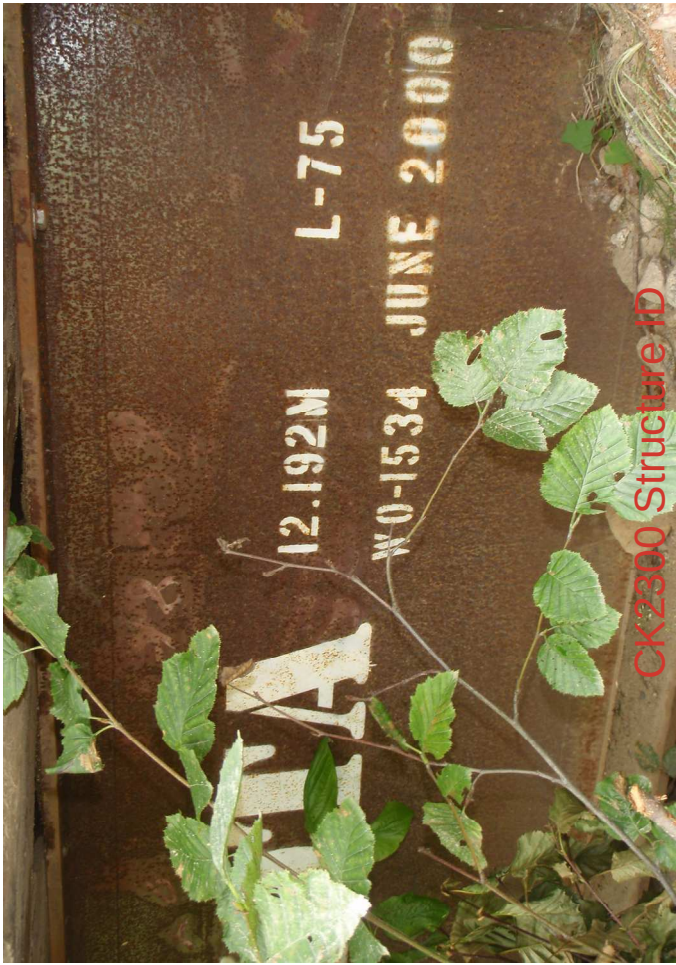
CK2300 Left abutment

CRIB NOT  
LOAD BEARING.FILL IN  
FRONT OF NEW  
SILLS. CRIB POTTED  
& LEFT CRIB, DOWN-  
STREAM IS BEING  
UNDERMINED.RIGHT ABUTMENT  
IS LOOSE.8" x 10" TIMBER. W/ 400mm C-C SPACING  
NOT VISIBLE DUE TO DEBRIS ON DECK.
