# Corporate Bridge Register (CBR) Structure Inventory Data Form "CULVERTS"

| *Forest Service Road: <i>SIMS CRK</i> | Kilometres: <i>3.8</i> |

## Routine Condition Culvert Inspection Form

2010-08-20

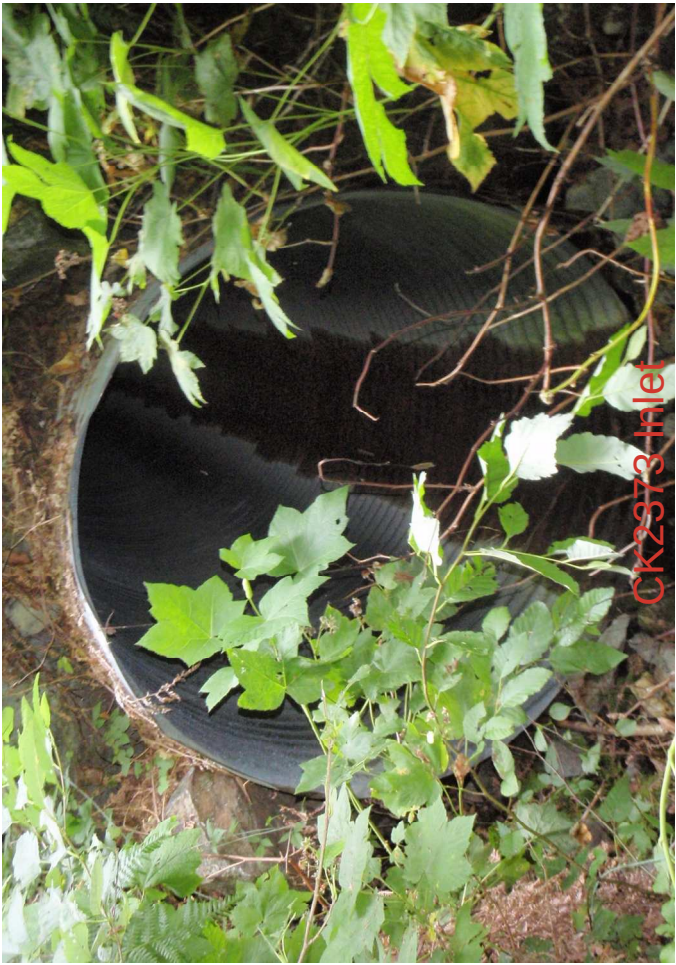
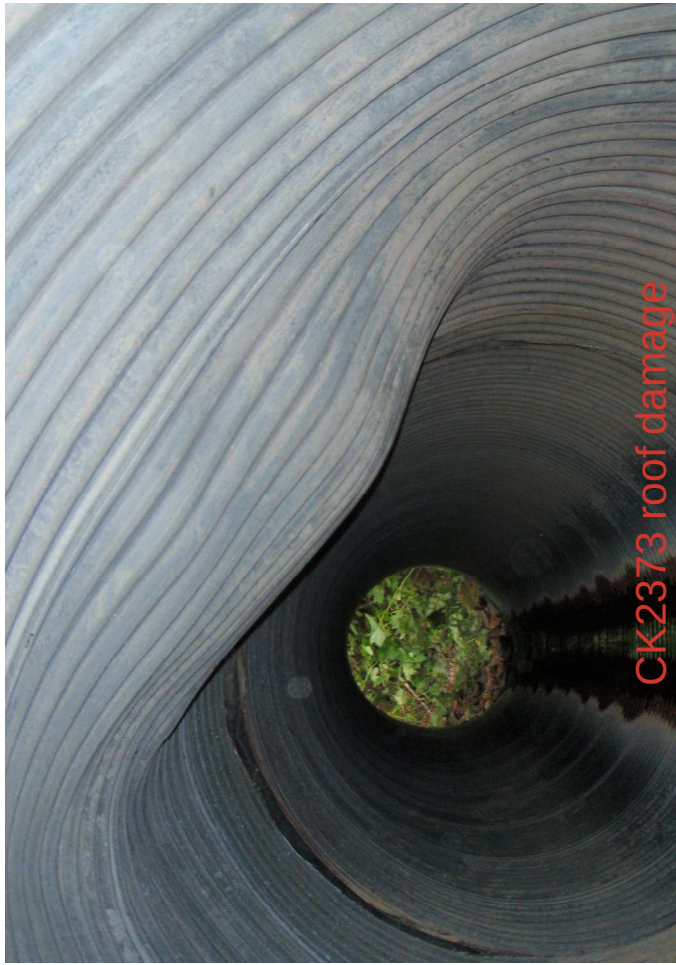
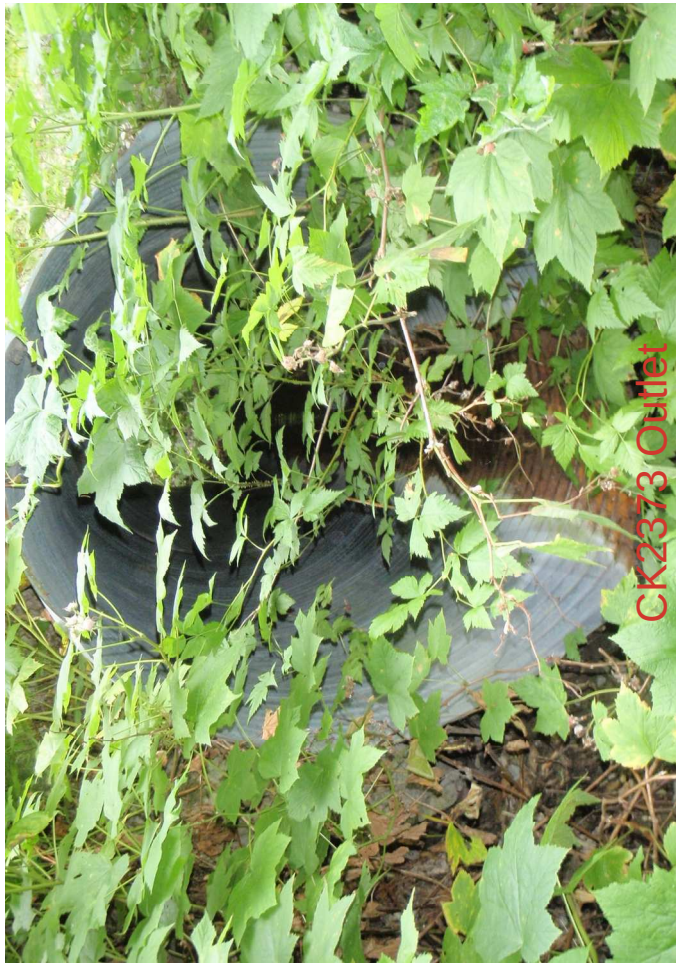
| GENERAL INFORMATION | | | | (enter either long/lat or UTM below - not both) | | |
|---|---|---|---|---|--|--|
| Roof | E G F <input checked="" type="radio"/> P UR | BADLY DAMAGED MOST LIKELY DUE TO INSTALL. | | | | |
| Inlet | E G <input checked="" type="radio"/> F P UR | INADEQUATE RIP RAP | | | | |

major culvert and road is restricted to 4WD access only.
