**Routine Condition Bridge Inspection Form**  
(except for log stringer or timber stringer bridges)**GENERAL INFORMATION**

| *Site ID: <u>6K-2109</u> | *Crossing Name: <u>Hornet Creek</u> | *Type/Class: <input checked="" type="checkbox"/> Temporary bridge<br><input type="checkbox"/> Permanent bridge | *Project File ID# <u>5748</u> |
| *FSR Name: <u>Harrison East</u> | *Forest District: <u>Chilliwack</u> | *Kilometres: _____ | User km: <u>03.43</u> |

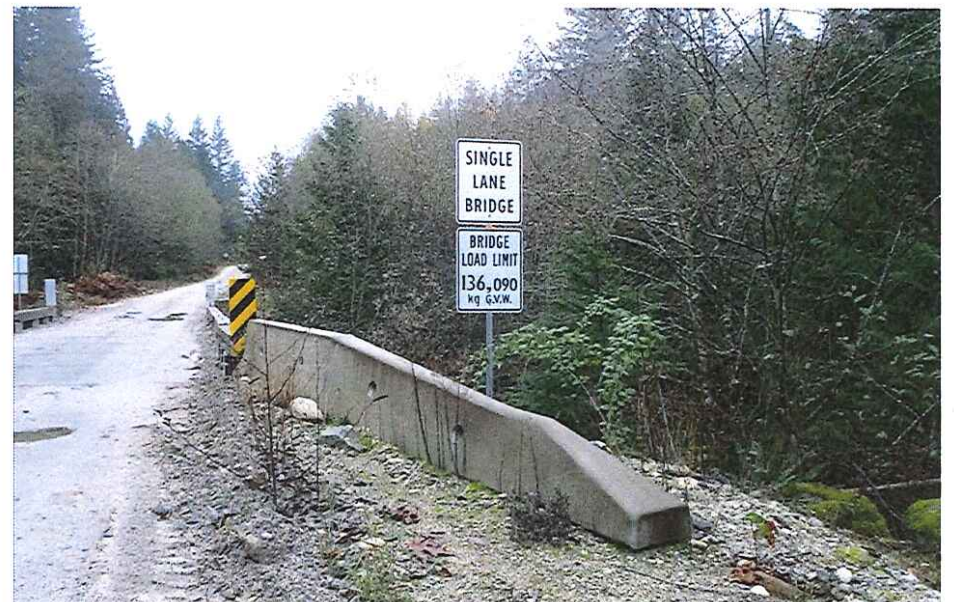
CK2109 Load Rating

| GENERAL INFORMATION | | | |
|---|---|---|---|
| PEng Reviewer's Comments<br><u>Monitor cribs. Present load rating of L150 or 136 tonnes.</u> | | | |
