**Routine Condition Bridge Inspection Form**  
(except for log stringer or timber stringer bridges)

| GENERAL INFORMATION | | | | (enter either long/lat or UTM below - not both) | | | |
|---|---|---|---|---|--|--|--|
| *Site #: <u>CK-2378</u> | *Crossing Name:<br><u>Winslow Side Channel</u> | *Type/Class: <input type="checkbox"/> Temporary bridge<br><input checked="" type="checkbox"/> Permanent bridge | *Project File ID# <u>2013</u> | | | | |
| *FSR Name:<br><u>Stave River</u> | *Forest District:<br><u>CK</u> | *Kilometres: | User km: <u>17.7</u> | | | | |

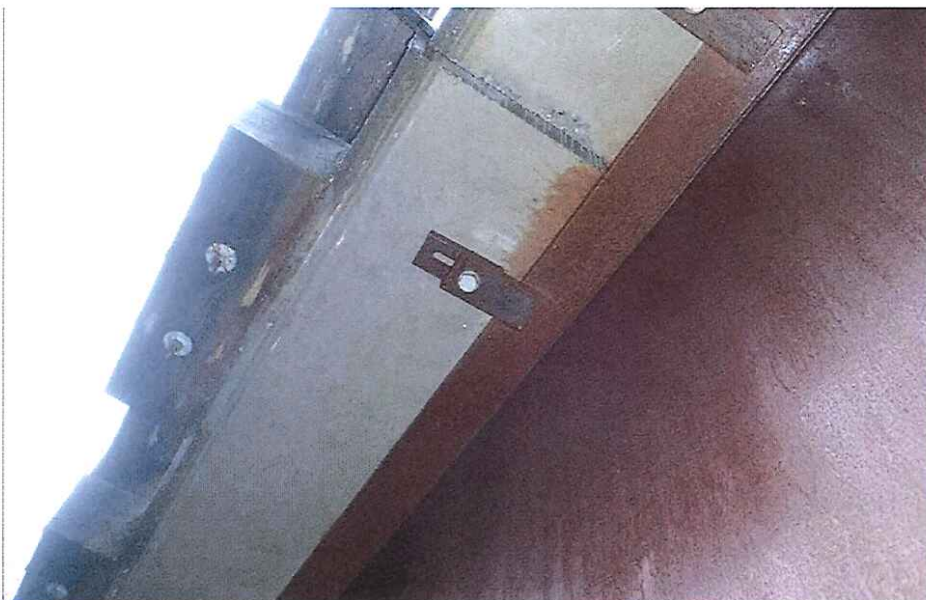
CK2378 Deck clips

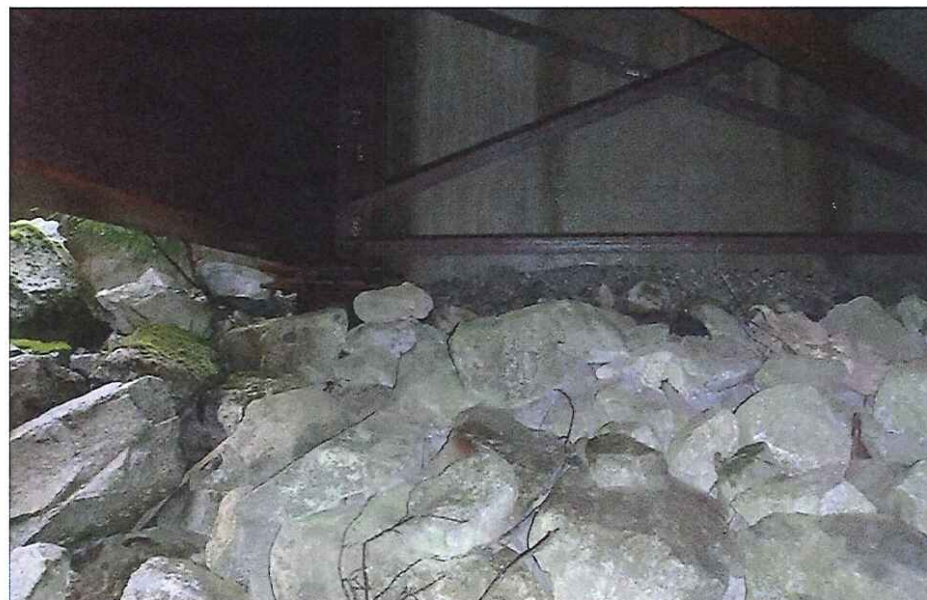
CK2378 Left Abutment

| Item | Present Condition<br>(circle) | Comments<br>(a comment is mandatory if condition "Poor" is selected) |
|---|---|---|
| Ballast Wall | E G F <u>P</u> N/A UR | LEFT GOOD/LIGHT HAS, EXPOSED REPAIR |
