## Corporate Bridge Register (CBR) SITE INVENTORY DATA FORM

Routine Condition Bridge Inspection Form  
(except for log stringer or timber stringer bridges)

\*Crossing Name: Side Creek

| GENERAL INFORMATION | | | |
|---|---|---|---|
| 2013/09/25 | ONSITE | Jeremy Araki | C. R. ARAKI #29756 |

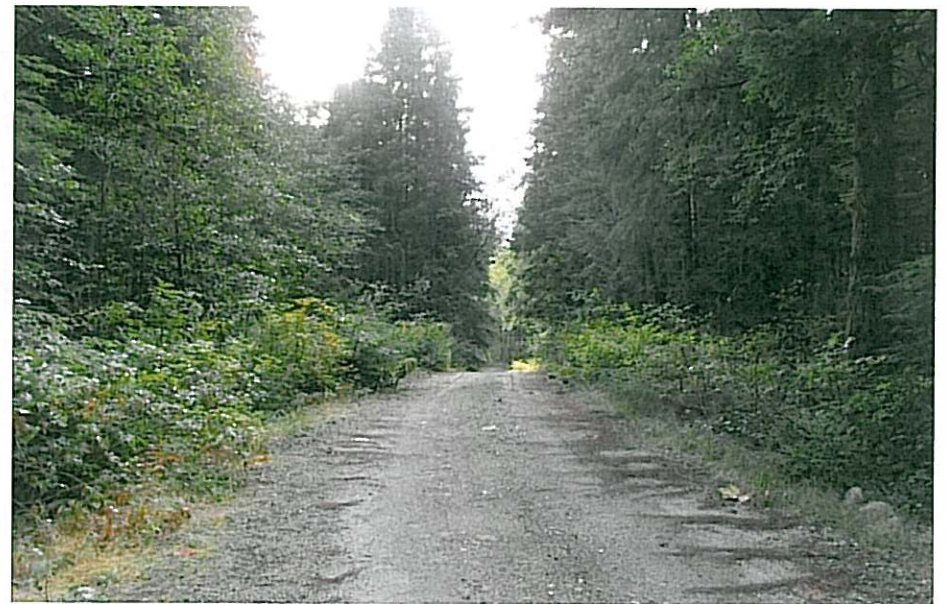
CK-2353 Guard Downstream

| Item | Present Condition (circle or fill-in) | Comments (a comment is mandatory if condition "Poor" is selected) |
|---|---|---|
| Fender Condition | E G F <b>P</b> None UR | Downstream right approach no post barriers have been hit and now lie in the ditch. |

| GENERAL INFORMATION | | | |
|---|---|---|---|
| 1 | H M L | \$1.00 | Replace sills. Replace rails before industrial activity occurs. |
