CK-2051

CHILLIWACK RIVER 8.1km

2015 Inspection

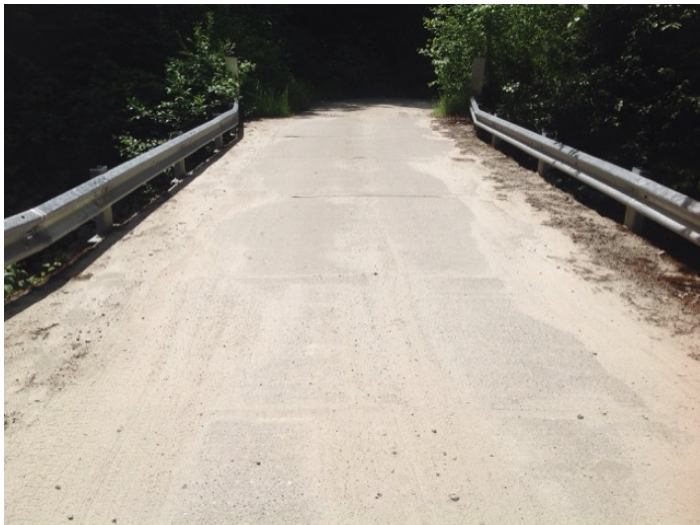
Deck Joints      Fair      some sealant popping out and requires replacement

sealant worn and failing

| 2 | Medium | replace all deck sealant prior to industrial activity |
