CK-2136

STS'AILES 31.1km

2015 Inspection

| Crossing Name | Mystery Creek |

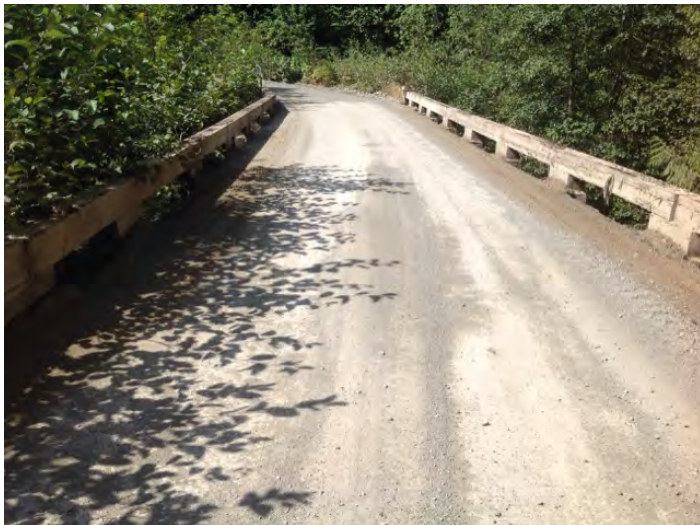
Concrete Deck Fair track damage and rebar exposed at approaches

| Repair Item | Priority | Repair Description |
|---|---|---|
| 2 | Medium | repair exposed rebar on running path of deck panels |
