CK-2444

NORRISH CREEK 12.9km

2015 Inspection

| Crossing Name | Cyr Creek |

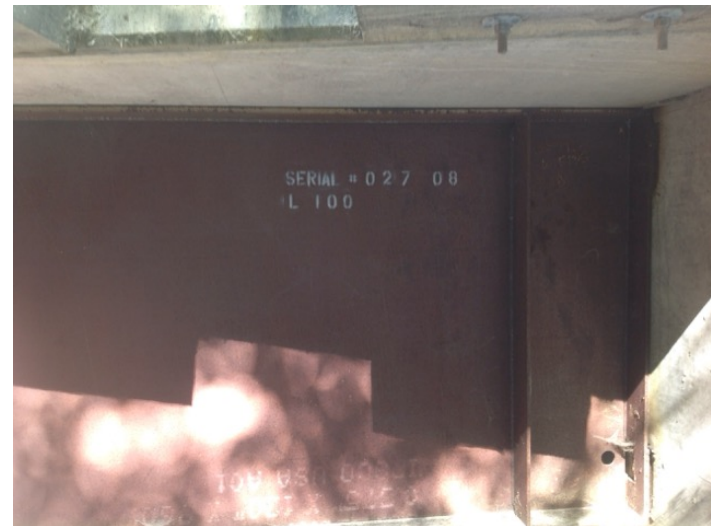
ballast wall and deck damage on both approaches

Repair damaged panel. Present load rating of L100 or 91 tonnes to continue.
