2494

NORRISH WEST 0.1km

2015 Inspection

| Crossing Name | Dickson Creek |

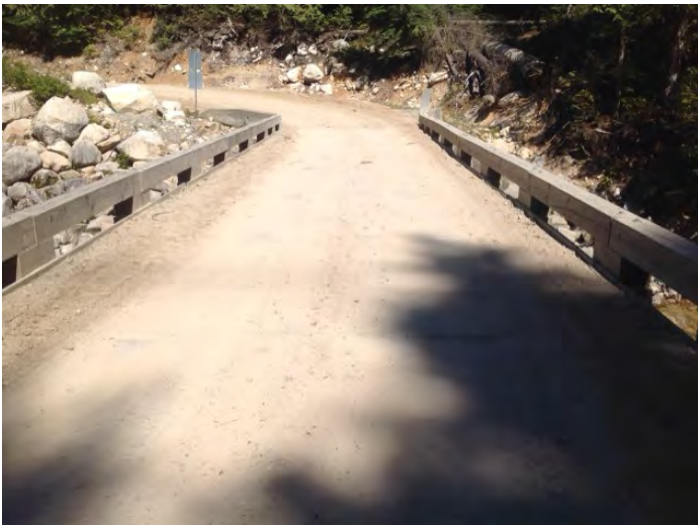
Concrete Deck Fair damage to many of the deck panels

Overall Deck Condition Fair

Many of the deck panels have sustained damage; I recommend repairing all of the damage ones before further damage is done. Replace all deck seals. Replace missing delineator. The present load rating of L75 or 68 tonnes can continue.

Comments recommend removing all panels and repairing - much damage sustained

| Repair Item | Priority | Repair Description |
|---|---|---|
| 1 | High | deck panels damage |
