CK-2019

CAYOOSE CREEK 0.1km

2016 Inspection

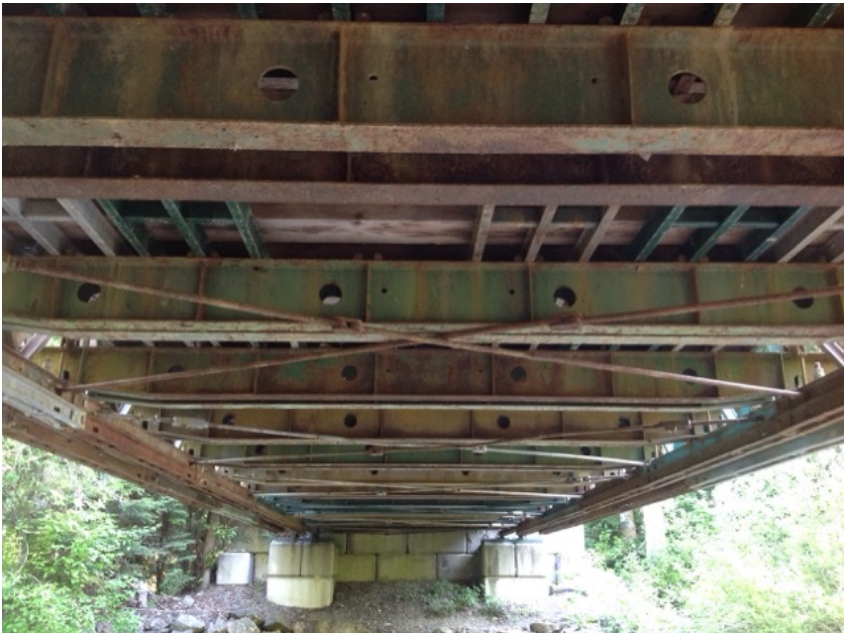
superstructure

double single reinforced Acrow/bailey with some corrosion

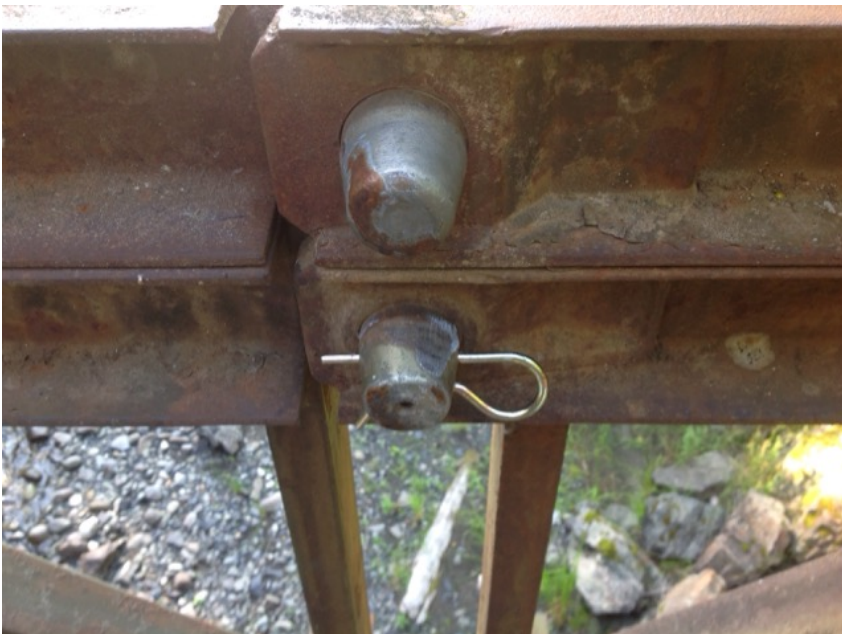
existing clip

| Repair Item | Priority | Repair Description |
|---|---|---|
| 2 | High | replace missing clips prior to industrial use |
