CK-2169

LOST CREEK 14.6km

2016 Inspection

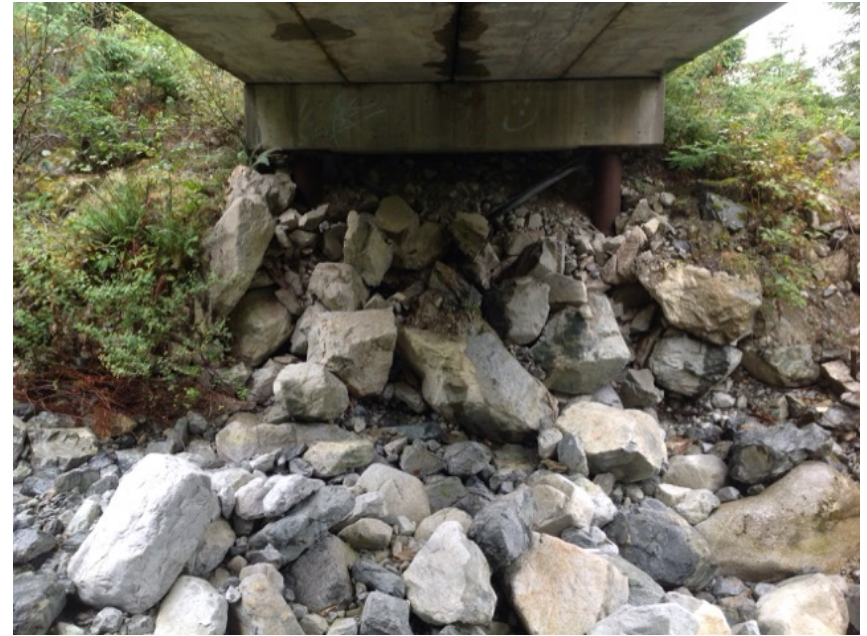
Left Bank Abutment when facing downstream

Riprap Fair poor on left bank as scour noted

| 1 | Medium | repair riprap scour prior to heavy rains |
