CK-2224

PITT RIVER 23km

2016 Inspection

| Crossing Name | Shale Creek | | |

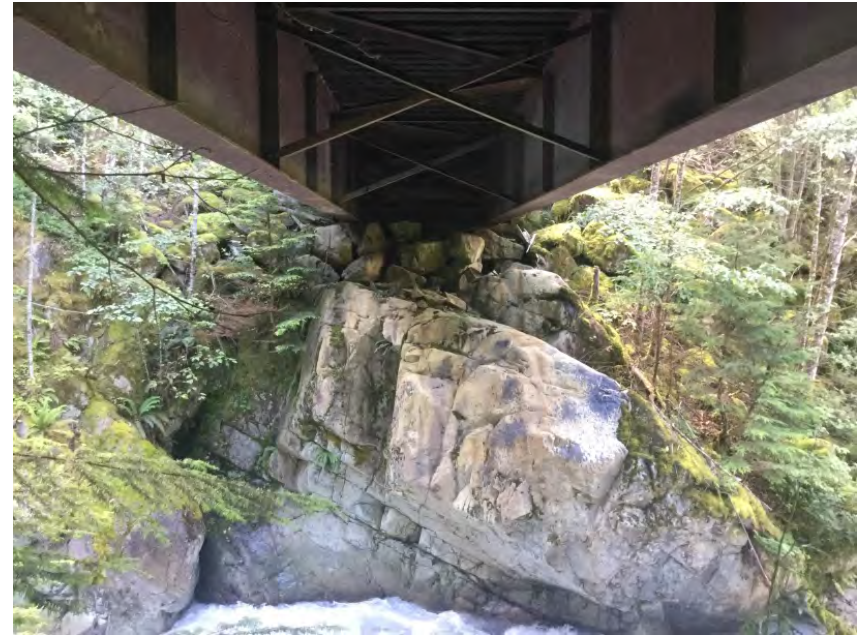
Left Bank Abutment

Some minor heart rot at ends. No crushing or distress noted.

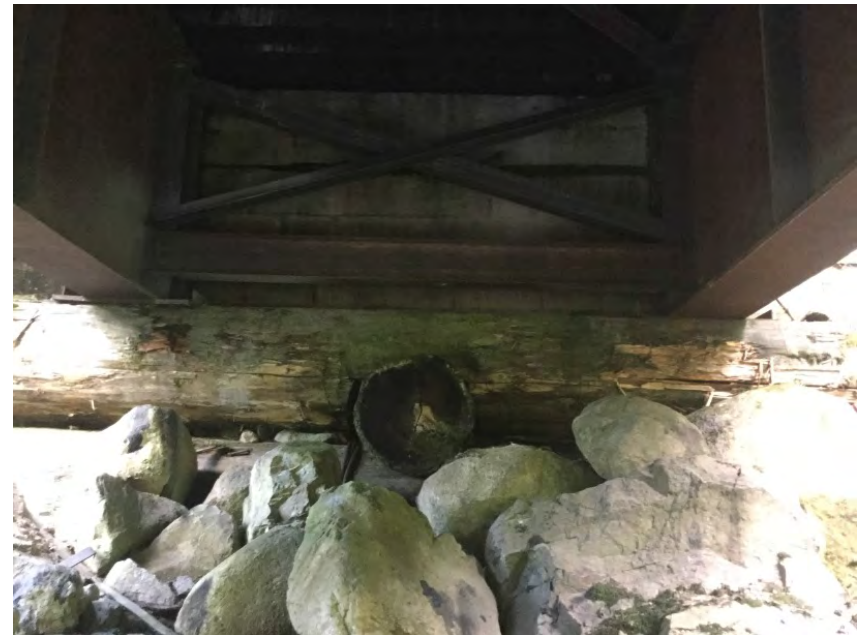
Right Bank Abutment

Typical 25 mm sap rot under girders. R/B U/S corner under girder, horizontal split in top crib log with signs of bug infestation. No crushing or distress noted. No rot identified in cores.

| Item | Monitor Description | Frequency |
|---|---|---|
| 1 | Monitor deterioration of right abutment log crib. | Routine Inspection |
