CK-2235

SCUZZY CREEK 6.6km

2016 Inspection

Inspection Company SNT Engineering

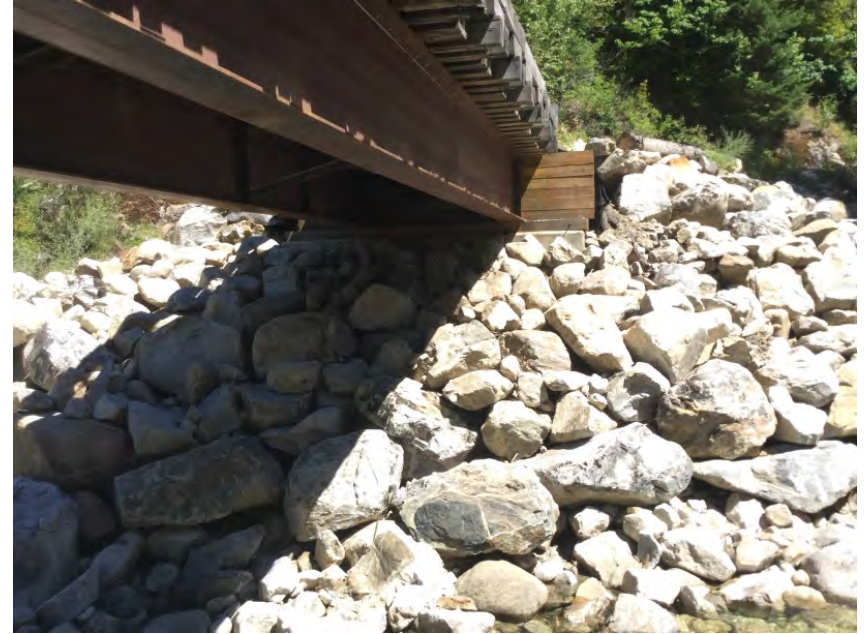
Left Bank Abutment

Concrete Good Lock blocks appear to have been replaced since previous inspection.

Caps or Sills Good Timber sill replaced since previous inspection. Girders bear evenly on sill.
