CK-2240

SPUZZUM CREEK 5km

2016 Inspection

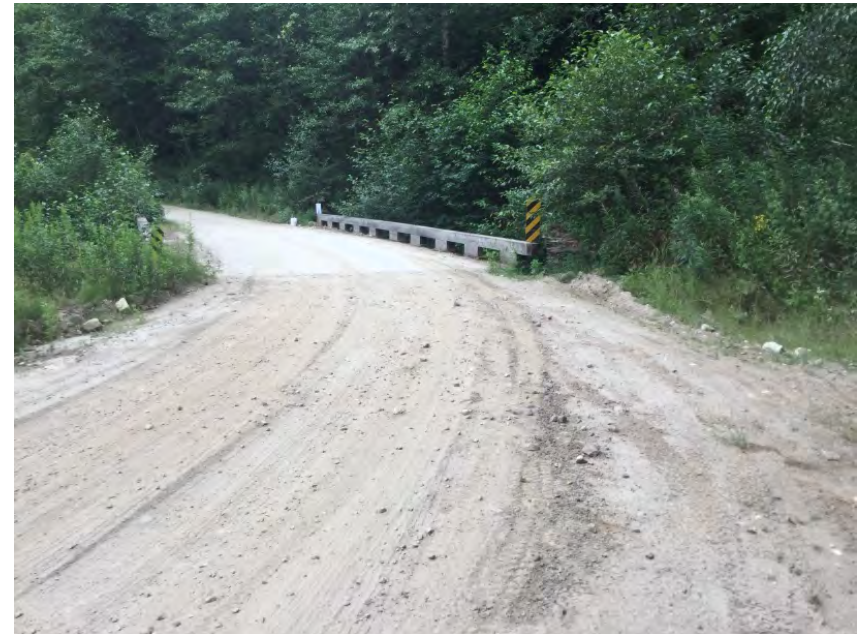
Left Approach Facing Bridge

| Running Surface | Fair | Left approach is below the level of the deck, resulting in damage to girder ends. 1500 mm long by 700 mm erosion at left abutment upstream corner. |

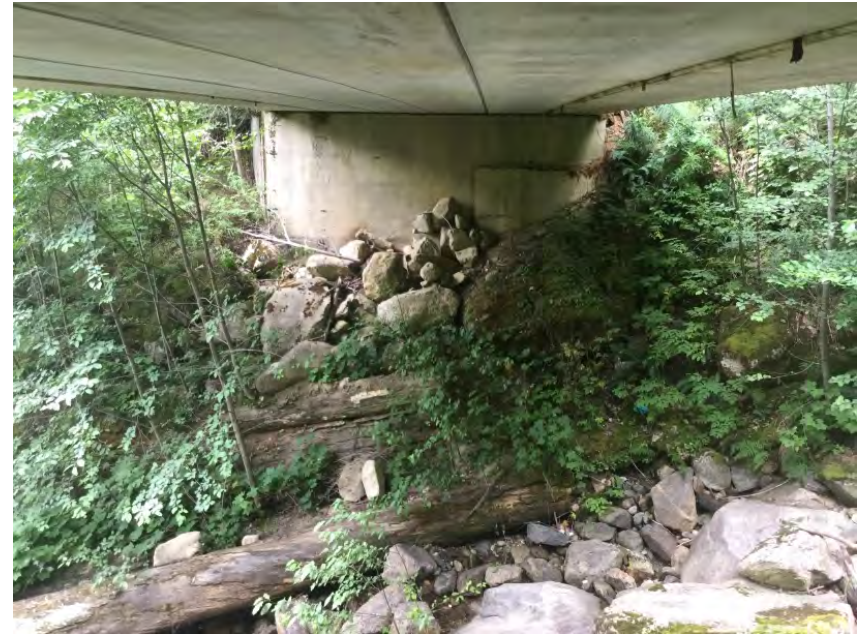
Right Bank Abutment

Downstream corners only. Right abutment wing wall not cast high enough, requiring log and lashing to retain fill at deck elevation. Log is rotten and in poor condition.

| Item | Priority | Repair Description |
|---|---|---|
| 2 | High | Install new guide logs at all corners. Significant drop to creek at downstream side. Also replace rotten log at right abutment downstream side that retains fill. Alternative options such as lock blocks to be considered. |
