CK-2241

SPUZZUM CREEK 25.4km

2016 Inspection

Inspection Company SNT Engineering

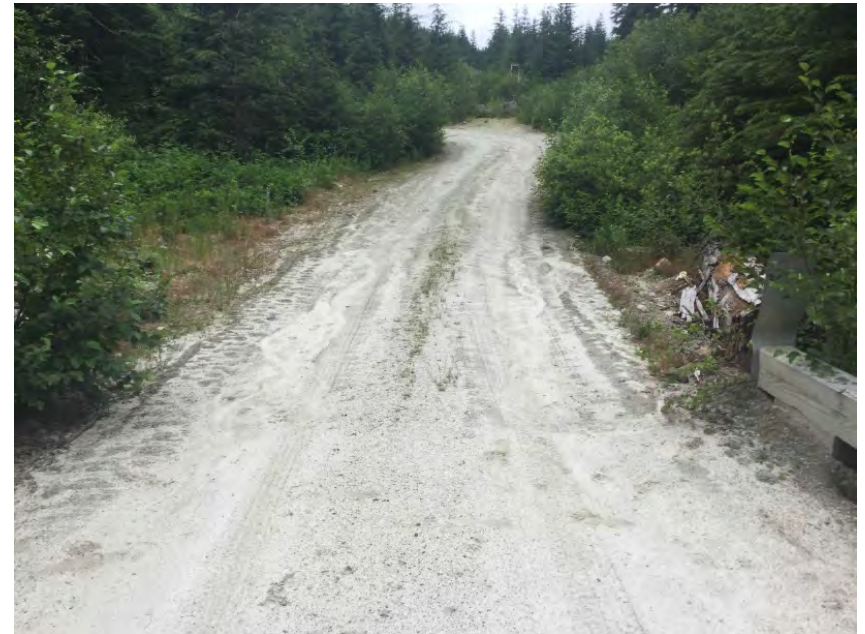
Right Approach Facing Away From Bridge

Right approach below level of deck resulting in damage to ballast wall. Potholes and signs of ponding.

| Item | Priority | Repair Description |
|---|---|---|
| 3 | Medium | Repair left abutment ballast wall, regrade and brush approaches for industrial use. |

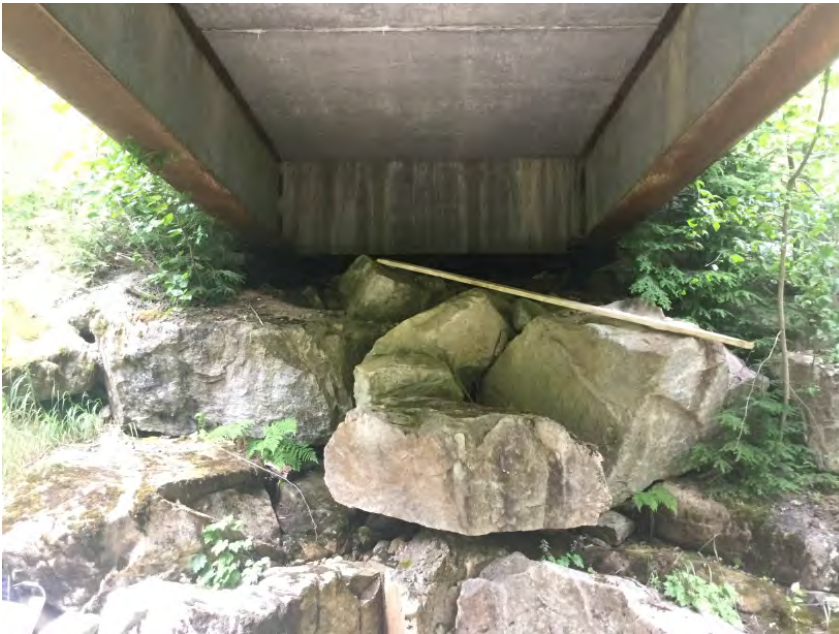
Left Bank Abutment

Left Abutment: spall in wheel track with exposed rebar and spall in upstream tapered section of ballast wall.
