CK-2263

STAVE RIVER 11.4km

2016 Inspection

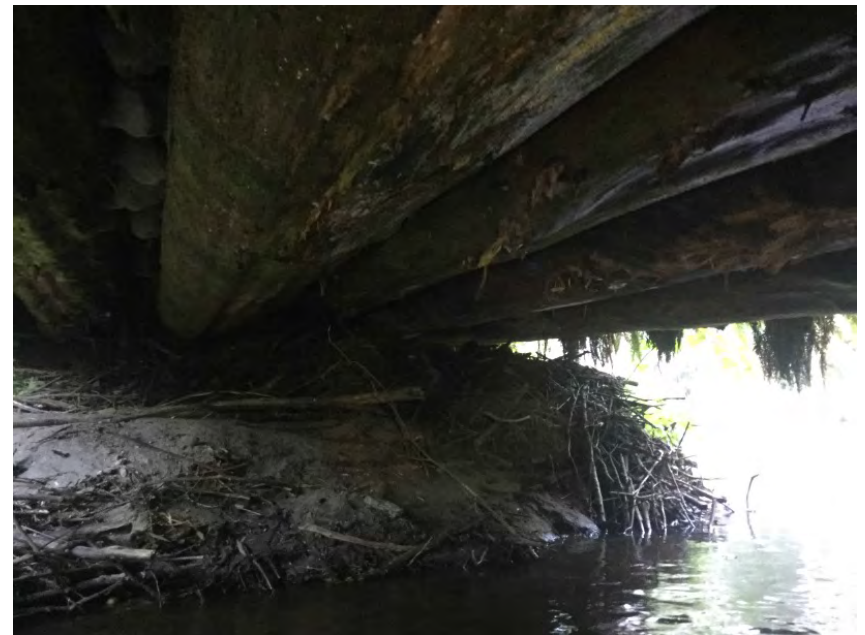
Stringers

| Stringer<br>Number | Species | Peeled | Diameter<br>(mm) | Rot Depth<br>(mm) | Condition | Comment |
|---|---|---|---|---|---|---|
| 2 | Cw | Y | 760 | 0 | Fair | 20 sap rot. Knots. Fungus. 2015 insp: 40 rot. |
| 3 | Fd | Y | 920 | 0 | Fair | No sap rot. Fungus. 2015 insp: 30 rot. |
| 4 | Cw | Y | 620 | 0 | Fair | 20 sap rot. Lots knots. 2015 insp: 60 rot. |
| 5 | Cw | Y | 930 | 0 | Fair | 30 sap rot. Limited access. 2015 insp: 50 rot. |
| 6 | Cw | Y | 750 | 0 | Fair | 15 sap rot. Lots knots. 2015 insp: 50 rot. |
| 7 | Cw | Y | 680 | 0 | Fair | 60 sap rot. 2015 insp: 60 rot. |
