CK-2267

STAVE RIVER 19km

2016 Inspection

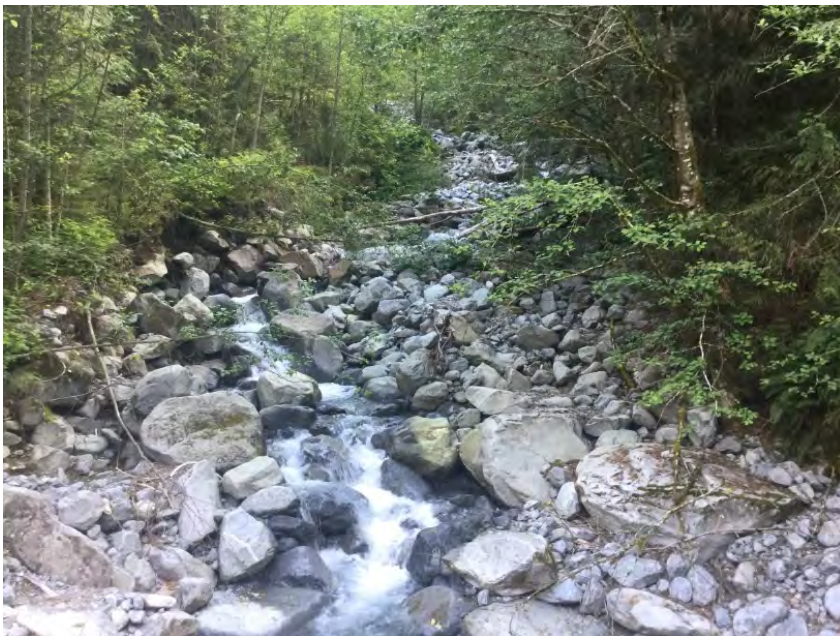
Looking Upstream

Comments Significant debris build up at upstream right corner, restricting channel flow. 300 mm of scour behind logs at left abutment upstream corner, where infill log is missing.

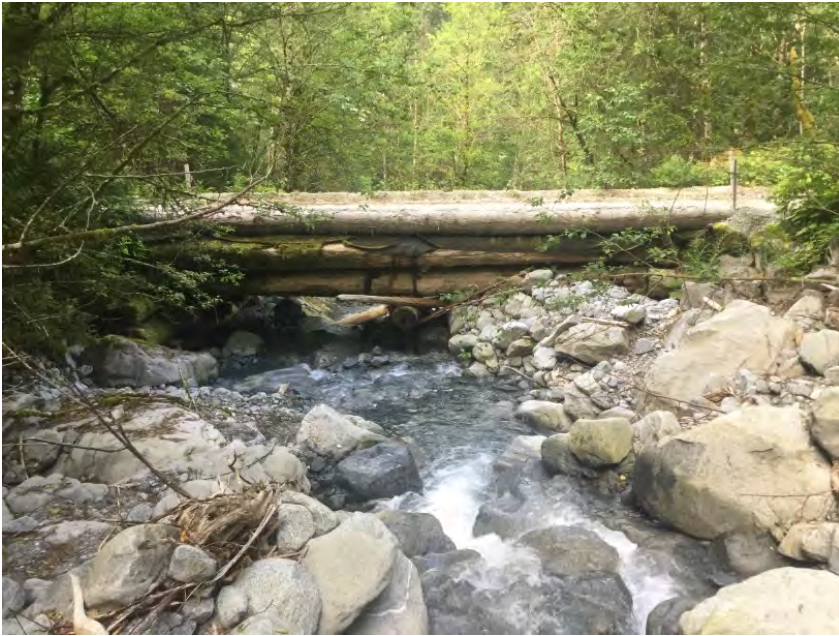
Upstream Elevation

Top log collapsed at upstream end of left abutment. Vegetation growing out of top logs. 50 mm sap rot on lower logs.

| Item | Monitor Description | Frequency |
|---|---|---|
| 1 | Monitor condition of left abutment prior to replacement or confirmation that top logs bear on alternate abutment. | Anually |
