CK-2269

STAVE RIVER 21.6km

2016 Inspection

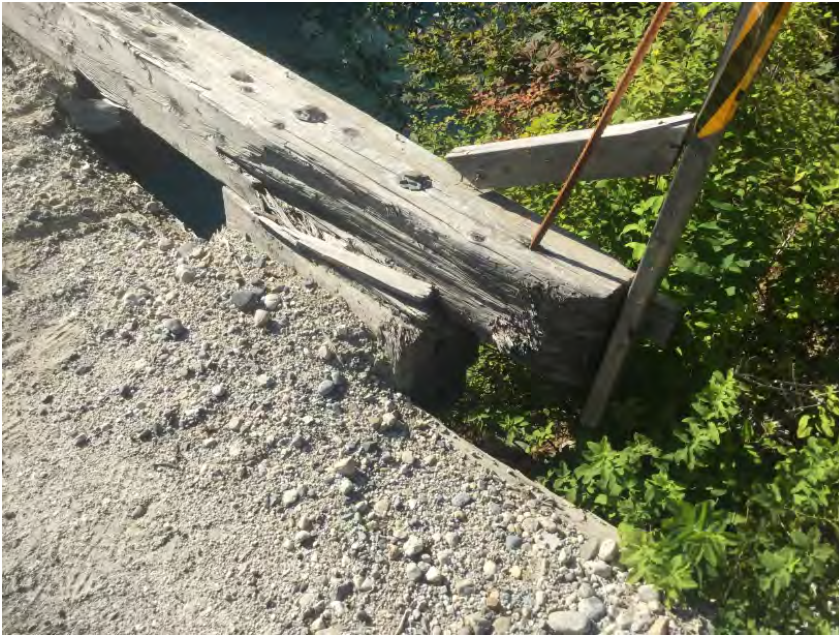
| Curb Rail/Blocks/Posts | Fair | 1 failed riser at L/B U/S corner. 1 split guardrail section. 4 end sections of guardrail have impact damage. |

Left Abutment Upstream Corner - Damaged Guardrail & Failed Riser

| Item | Priority | Repair Description |
|---|---|---|
| 2 | High | Replace damage/deteriorated guardrail sections. Requires 5 3050x250x250 mm sections and one 770x250x250 mm riser. |

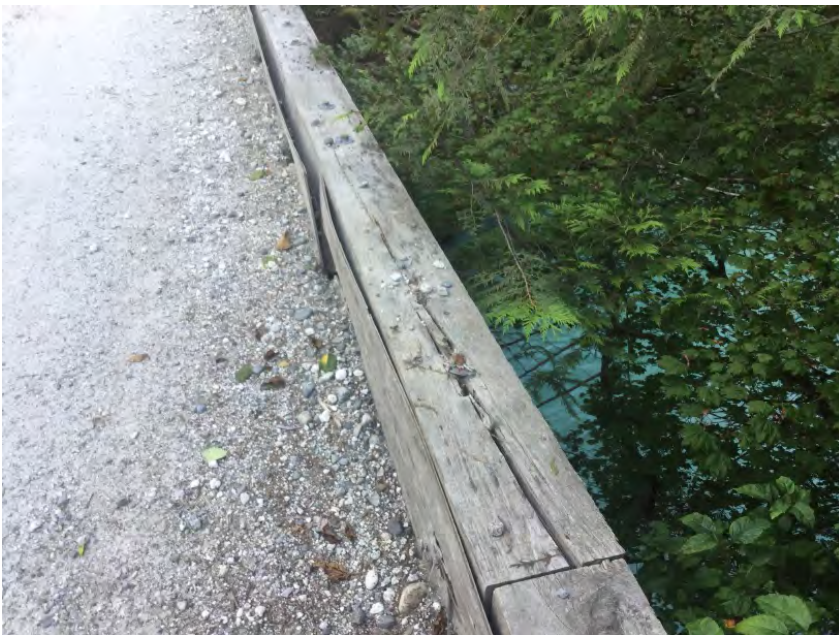
Split Section of Guardrail

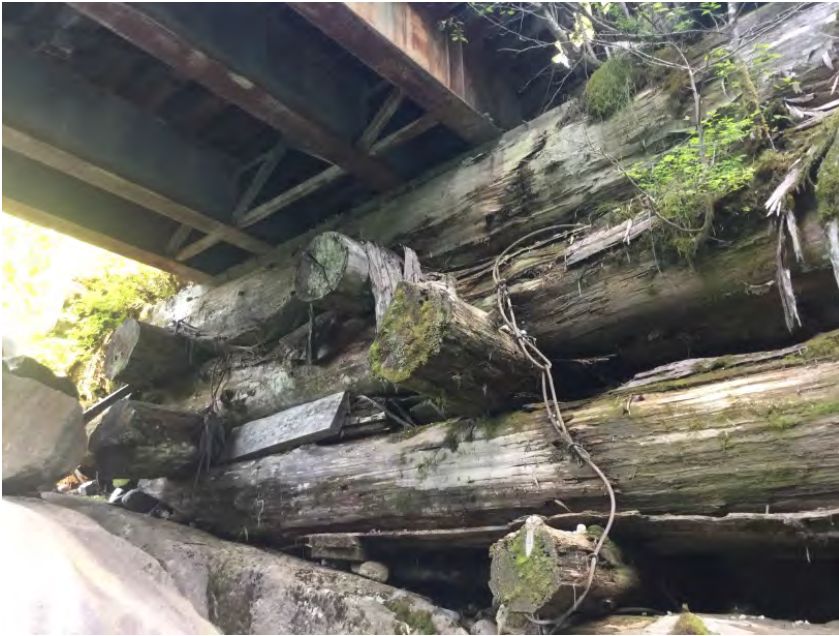
Left Bank Abutment

Left Abutment: Fair to poor. Limited access. Up to 50 mm sap rot. Trees growing out of some logs. No signs of crushing or distress.

There does not appear to be any change in the abutment condition; however its 30 years old and should be replaced soon - in the meantime monitor its condition. The timber deck was last replaced in 2009 (now 7 years old), therefore plan for a complete deck (ties, planks, guardrail and risers) replacement soon. In the meantime, replace the heavily worn planks and damaged sections of guardrail and risers. Reposition the concrete no post barriers at both approaches, post bridge ahead signs and brush approaches. The present load rating of L75 or 68 tonnes to continue.

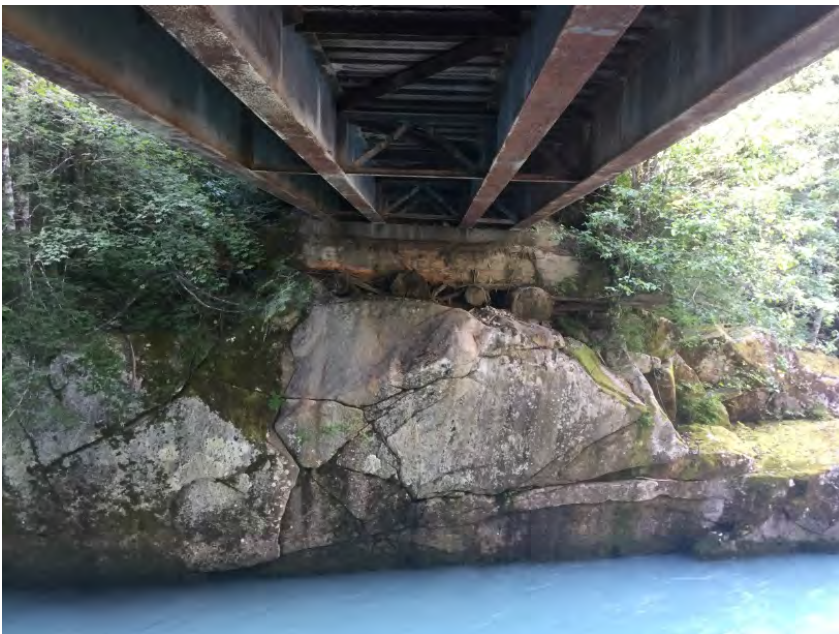
Right Bank Abutment

Fair to poor. Limited access. End splits and minor end rot. Trees growing in places. No signs of crushing or distress.

| Item | Monitor Description | Frequency |
|---|---|---|
| 2 | Access right abutment to inspect crib and determine cause bridge to slope to upstream side. | Other |

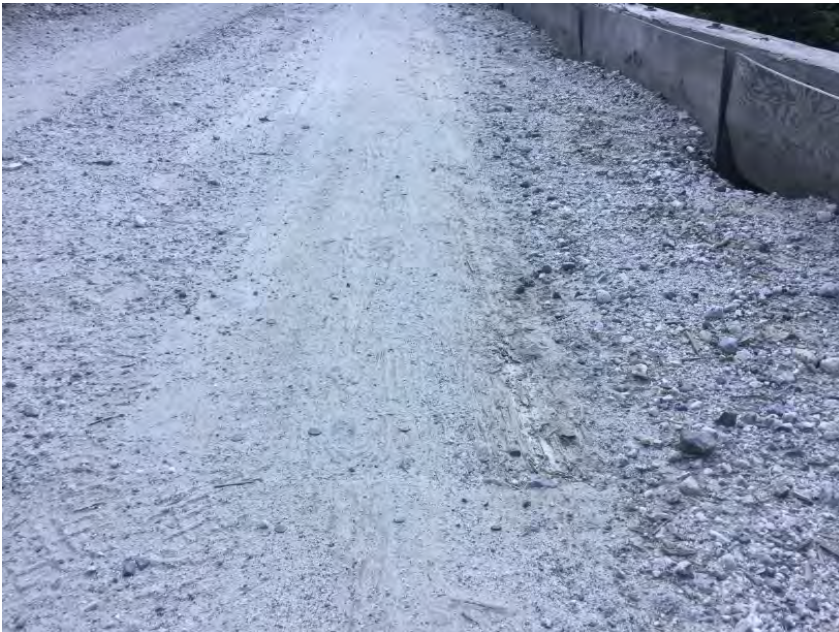
| Running Planks | Poor | Covered in debris. Moderate wear in wheel tracks with some spots of heavy wear. |

Area of Heavy Wear in Running Planks

| Item | Priority | Repair Description |
|---|---|---|
| 1 | High | Clean bridge deck and replace running planks in wheel tracks. Number of planks required to be determined after cleaning. |
