CK-2271

STAVE RIVER 26.2km

2016 Inspection

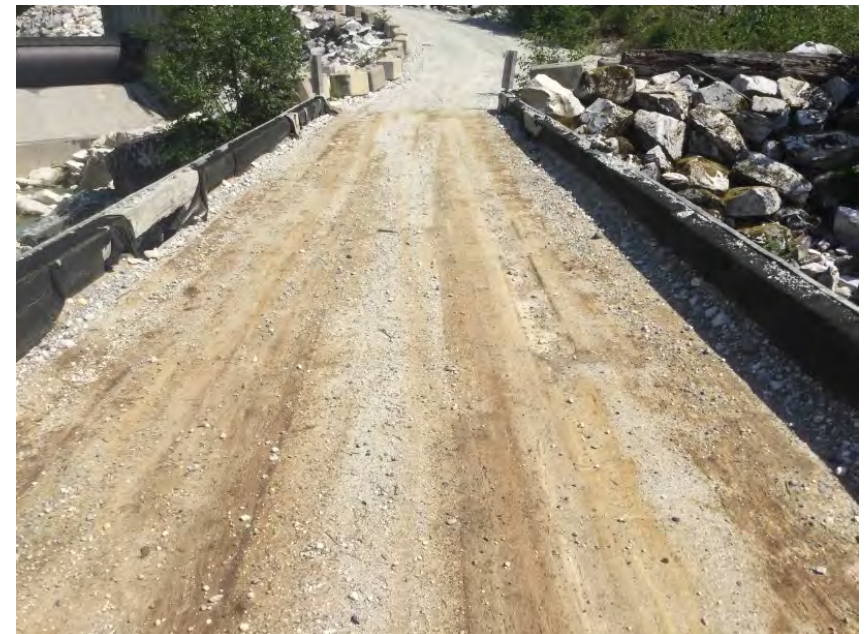
| Running Planks | Poor | Heavily worn. Debris accumulating on deck, and held in place by fabric covering guardrail. |
| Overall Deck Condition | Poor | Heavily worn running planks, rotten rises, damage and pockets of rot in guardrail. |

| Item | Priority | Repair Description |
|---|---|---|
| 2 | High | Replace running planks. Requires planks for 90 mm x 4.3 m x 24.5 m. Replace ties. Requires 2 5000x250x200 mm ties. Install longer fender at right approach downstream corner. Install load posting sign until repairs are performed. |

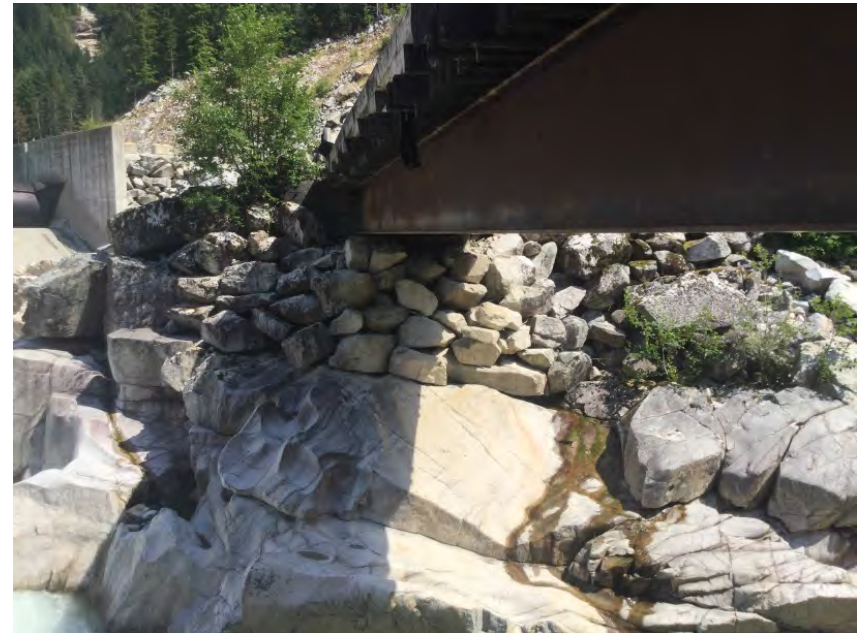
Left Bank Abutment

No access to R/B D/S bearing. Damage to R/B U/S bearing. L/B U/S bearing bulging.

| Item | Monitor Description | Frequency |
|---|---|---|
| 1 | Monitor bearing condition. | Routine Inspection |
