CK-2277

WINSLOW CREEK 0.9km

2016 Inspection

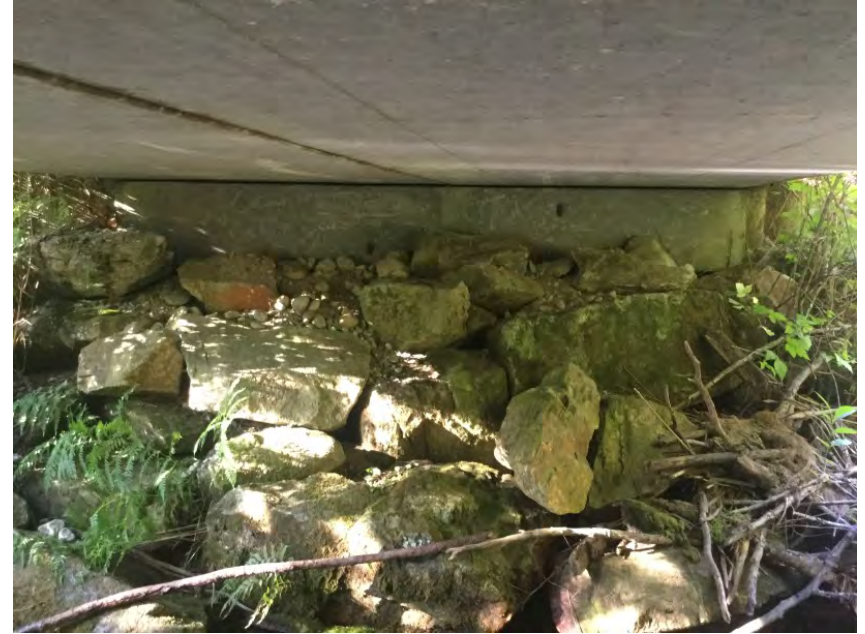
Right Bank Abutment

Gap between the cap and riprap has resulted in settlement of the approaches and damage to the ends of girders.
