CK-2331

STAVE RIVER 5.1km

2016 Inspection

| Crossing Name | Camp Creek | | |

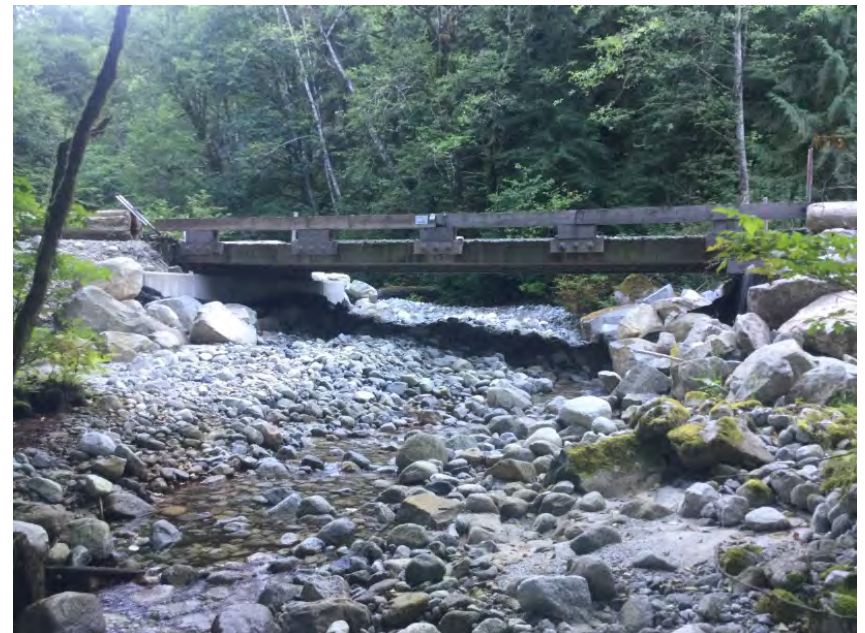
Downstream Elevation

Downstream delineator damaged.

Install bridge ahead signs; replace missing delineator and grade approaches. Present load rating of L75 or 68 tonnes to continue.
