CK-2353

WINSLOW CREEK 1.9km

2016 Inspection

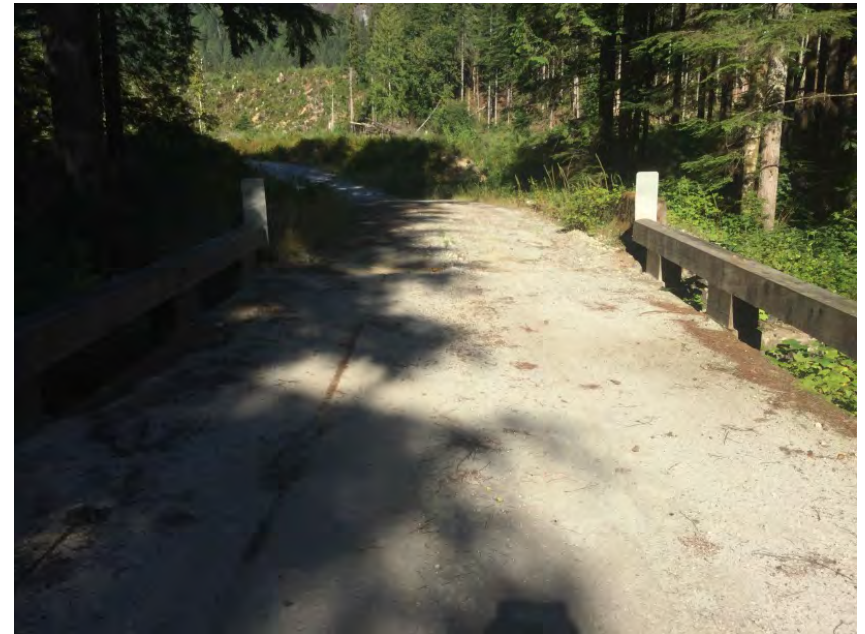
| Concrete Deck | Fair | Debris limited inspection. Wearing of surface, previous inspection identified damage from tracked vehicles, spall at slab joint. |
