CK-2378

STAVE RIVER 8.8km

2016 Inspection

| Crossing Name | Winslow Side Channel |

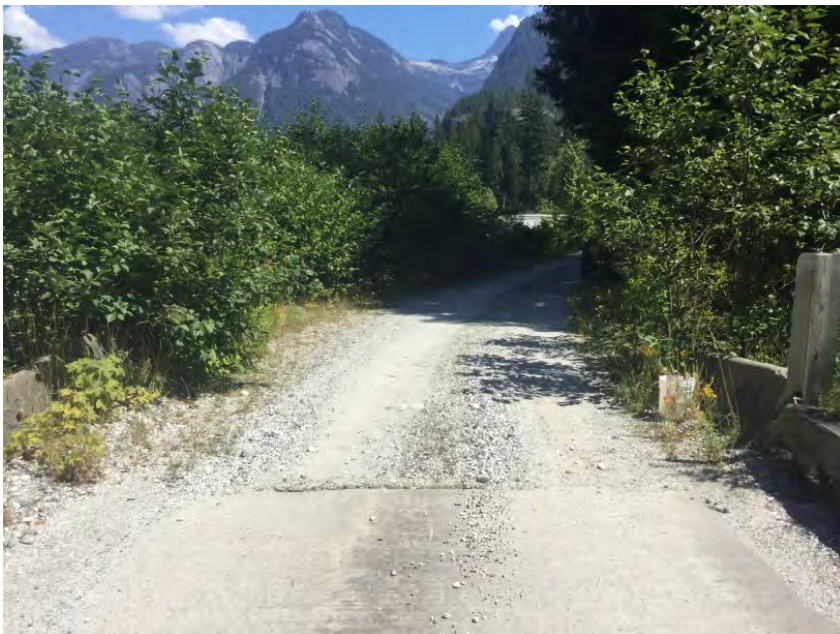
Left Approach Facing Away From Bridge

Road Surface Poor Road is below level of the deck resulting in damage to ballast wall and deck panel.

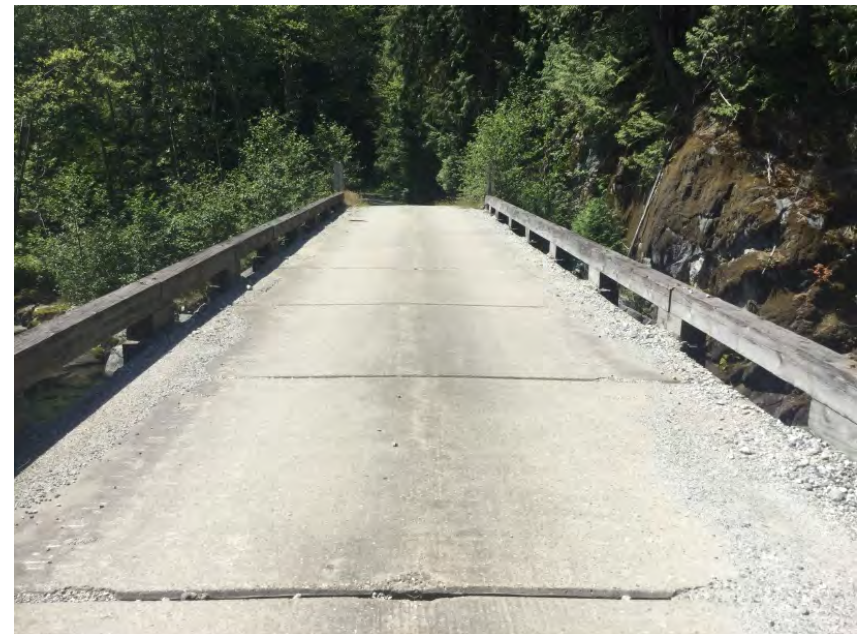
| Deck Joints | Poor | Compression seals have either fallen out or are damaged. |

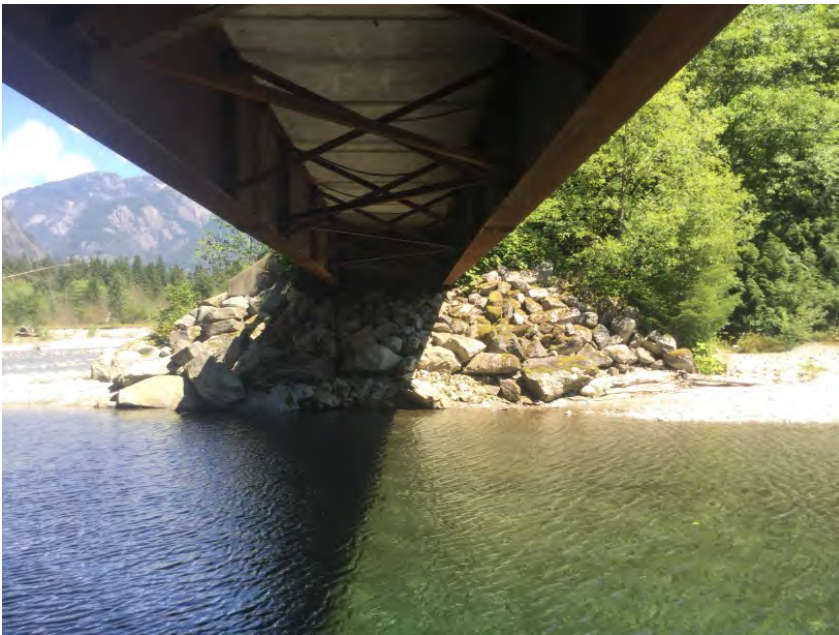
Left Bank Abutment

Ballast Wall Poor Damage to both abutment ballast walls. Spalling and exposed rebar. 90 mm gap to deck panel in wheel track at right abutment.

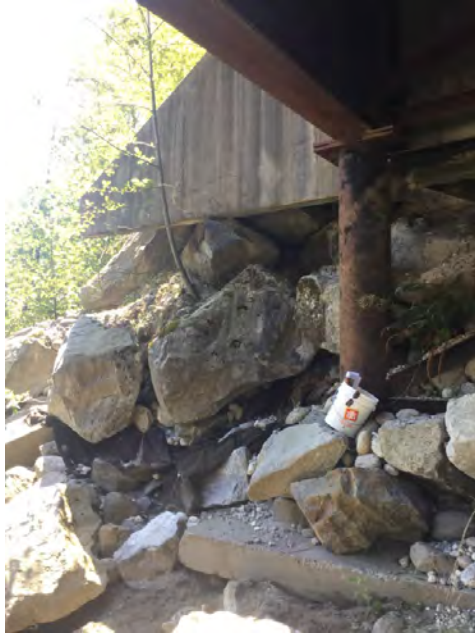
Right Abutment Downstream Corner

Right abutment ballast wall, guardrail, risers, blocking and compression seals require repair/replacement. Scour under right abutment footing appears similar to previous photos, but no measurements provided to allow comparison. Currently does not appear to affect stability of footing but will affect bearing capacity. Load posting recommended until repairs are performed. Monitoring required after each significant flow event.

Replace deck/compression seals; replace guardrail, risers and blocks; repair damage to ballast wall; reinstate bearing of the downstream right bank footing and provide scour protection; brush and grade approaches; replace missing barriers/fender at downstream right approach; and realign CRB at upstream left approach. Limit loading to 30 tonnes until work completed, post load rating sign. Monitor the scour under the downstream right bank footing.
