CK-2440

STAVE RIVER 31.8km

2016 Inspection

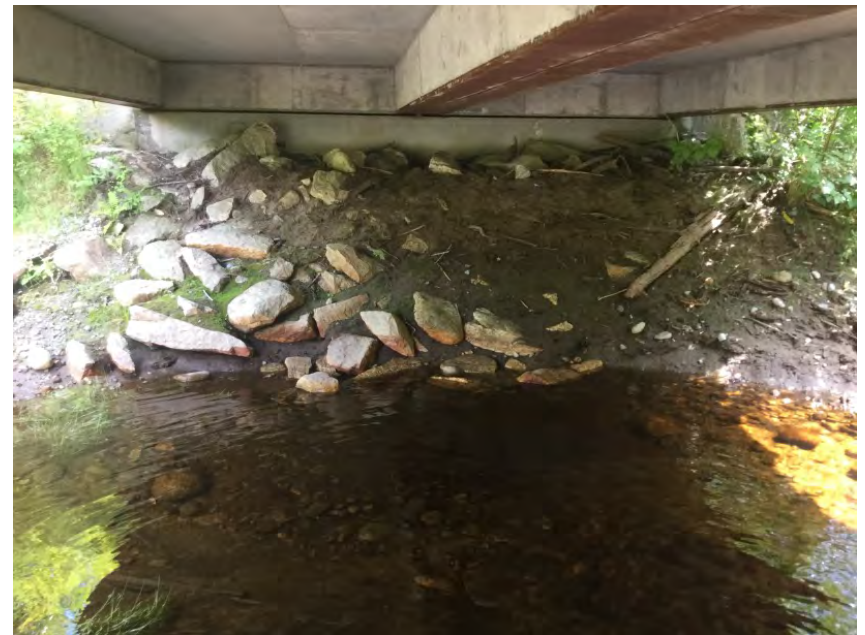
Left Bank Abutment

Precast concrete cap and ballast wall. Typical water staining.

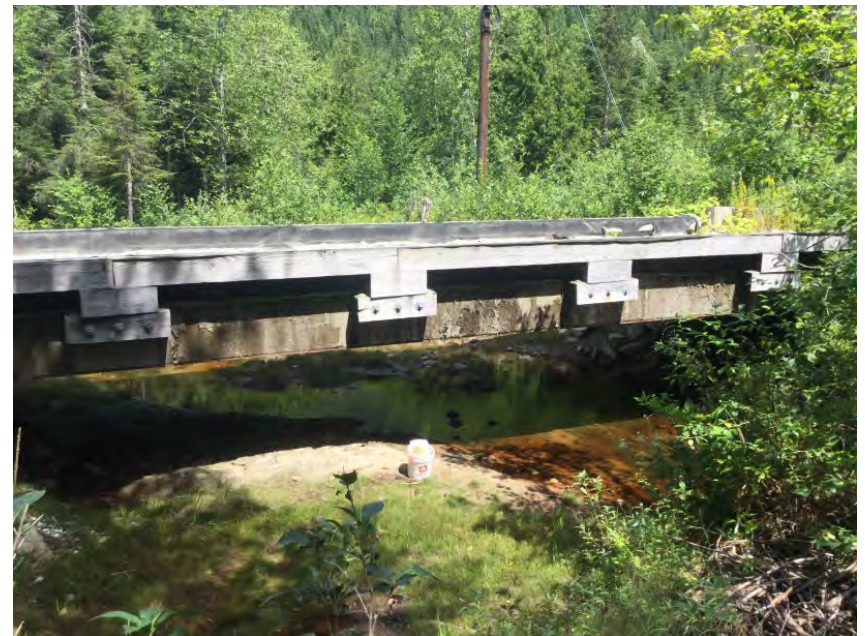
Downstream Elevation

Look like small compo girders with monolithic deck and end diaphragms. Typical watering staining on exterior faces.
