CK-2448

NORRISH CREEK 1.8km

2016 Inspection

| Crossing Name | Sally Creek | | |

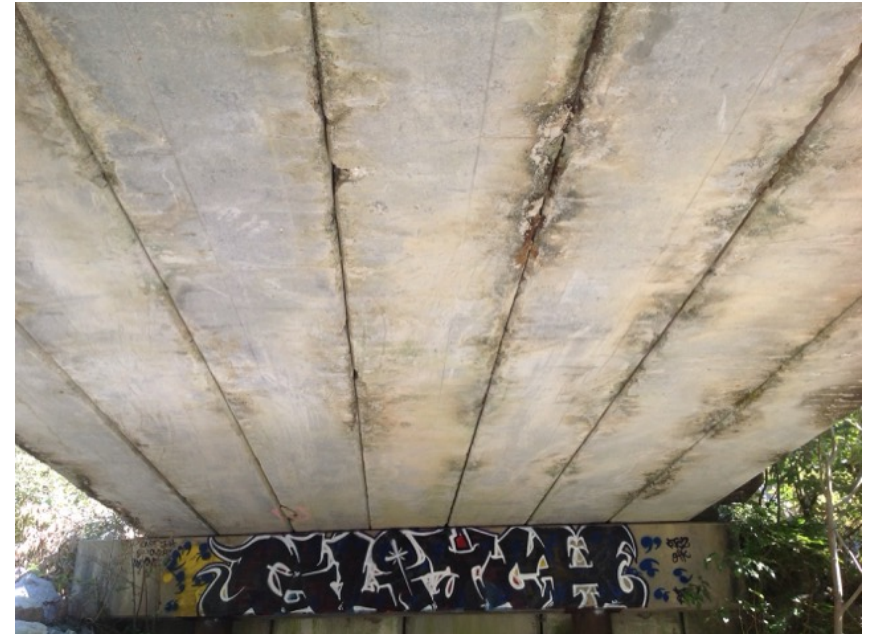
superstructure

Girders Fair 7 concrete slabs with spalls noted

| Repair Item | Priority | Repair Description |
|---|---|---|
| 3 | Medium | repair the girders in the areas with exposed rebar |
