CK-2504

Chehalis-Maisal 5.3km

2016 Inspection

| Structure Class | Temporary Bridge |

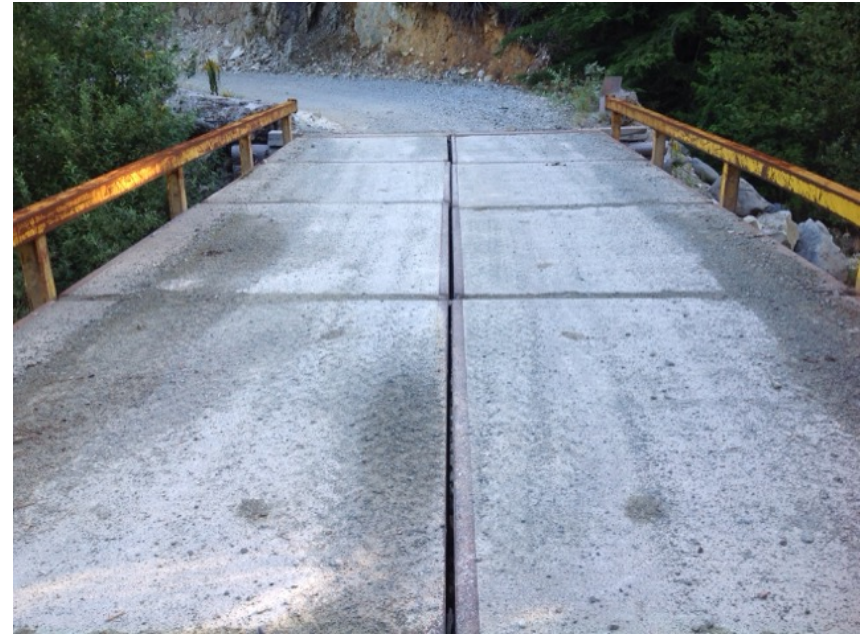
Deck

Curb Rail/Blocks/Posts Fair loose rail connection

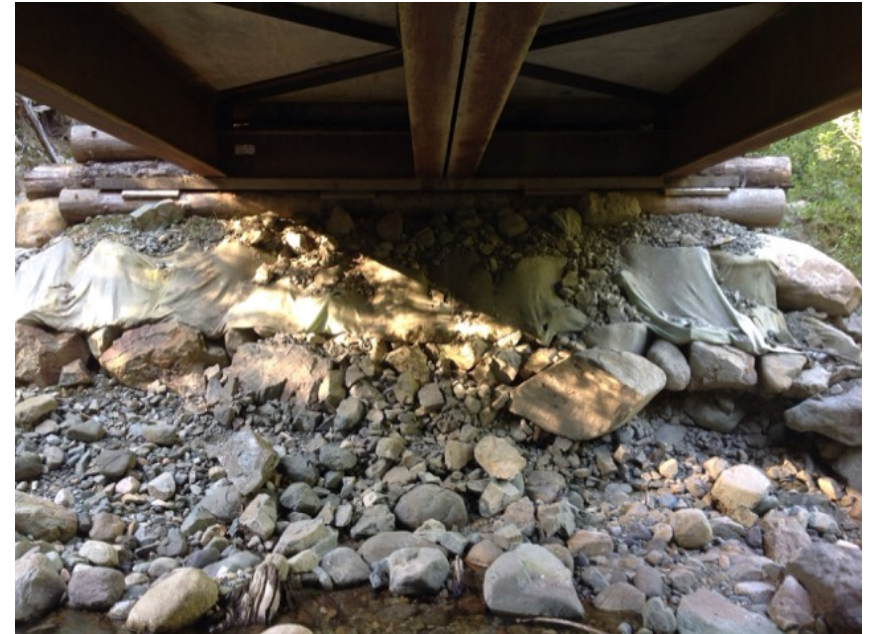
Left Bank Abutment when facing downstream

Caps or Sills Fair timber starting to crack

Repair eroded riprap on the downstream left abutment prior to industrial activity. Monitor the timber cap condition on top of the log sills. Considering this install was originally planned for 5 years or less (installed in 2013) consider deactivating the structure. Reduce loading to 40 tonnes until the riprap and bearing material have been replaced/stabilized. Replace missing delineator.
