CK-2506

Chehalis-Alf 0.2km

2016 Inspection

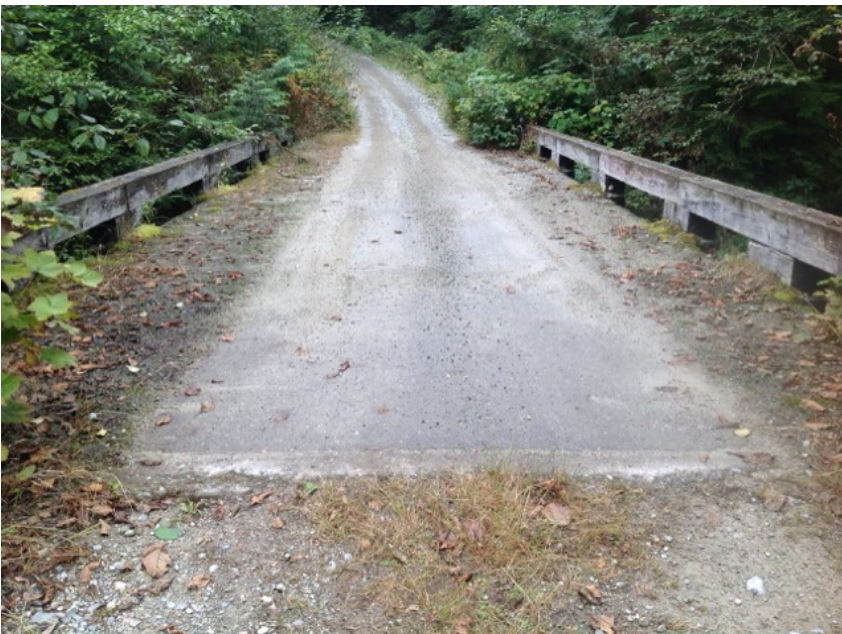
loose rail bolts

| Overall Deck Condition | Poor | due to rail condition |

| 2 | Medium | replace guardrail prior to activity |

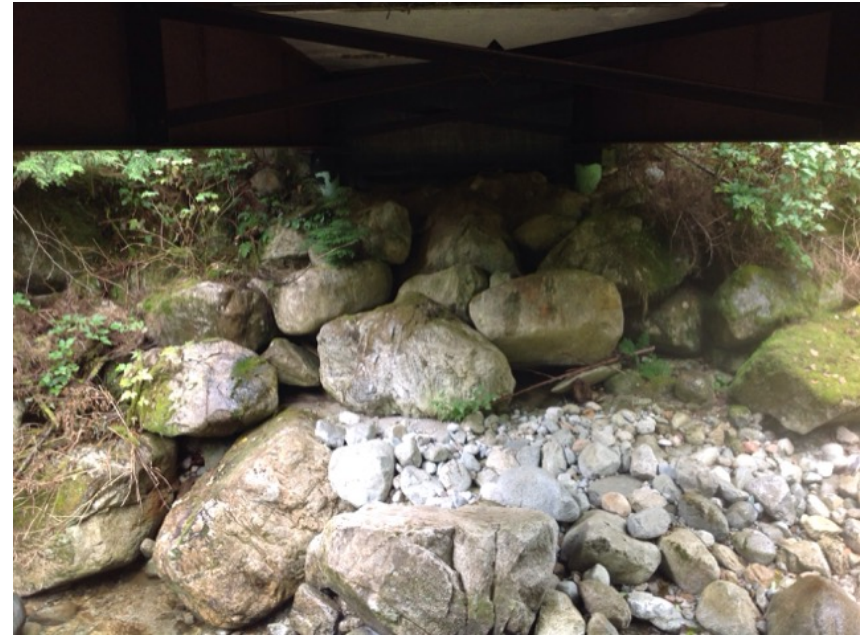
Right Bank Abutment when facing downstream

The right downstream precast footing is still undermined and subject to further erosion. The upstream footing is exposed and subject to erosion. The riprap is all rounded and not well graded or tied together which will lead to further erosion. The guardrail is rotten; there are missing bracing bolts; and the road is brushed in. I recommend a complete replacement for long term use. The present load rating of 40 tonnes to continue.

| 1 | High | repair undermined precast footing at right downstream |
