CK-2002

AMERICAN CREEK 4.6km

2017 Inspection

| Crossing Name | Three Mile Creek | | |

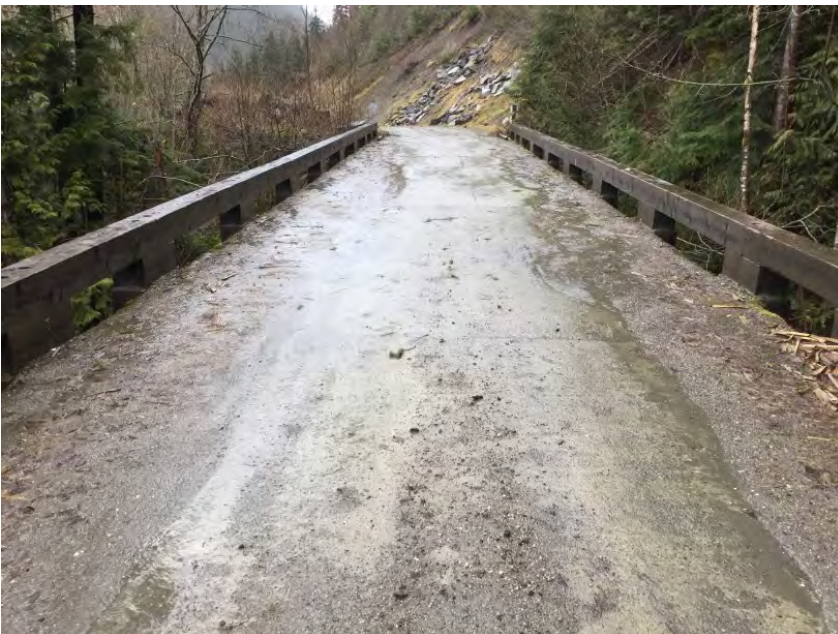
Concrete Deck Fair Minor damage on right bank panel

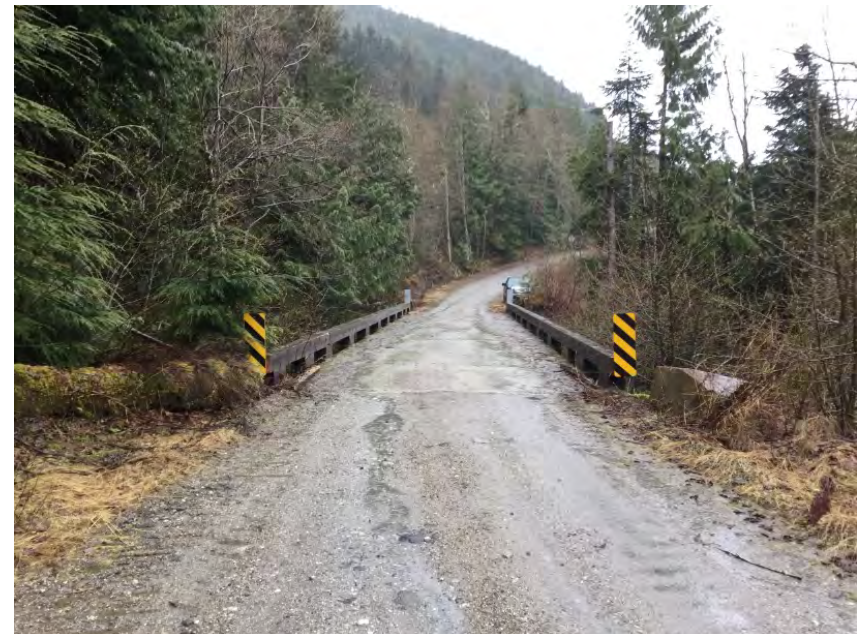
Approach from Right Bank when facing downstream

Delineator Missing  
Right ☐ 0 ☐ 1 ☒ 2

| Repair Item | Priority | Repair Description |
|---|---|---|
| 1 | Low | Replace both right hand delineator with proper ones |
