CK-2012

BLUE MTN TWO 0.8km

2017 Inspection

| Crossing Name | McFadden Creek |

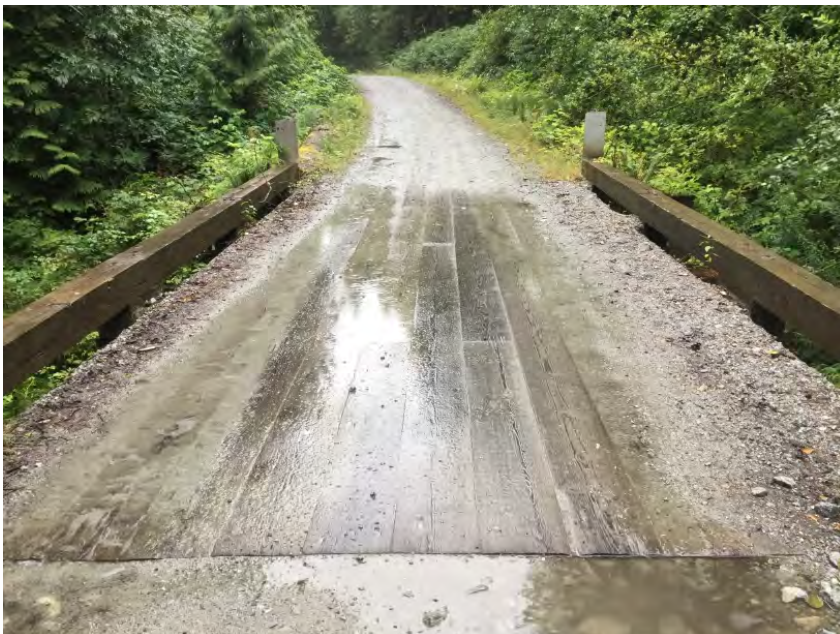
Overall Deck Condition      **Good**

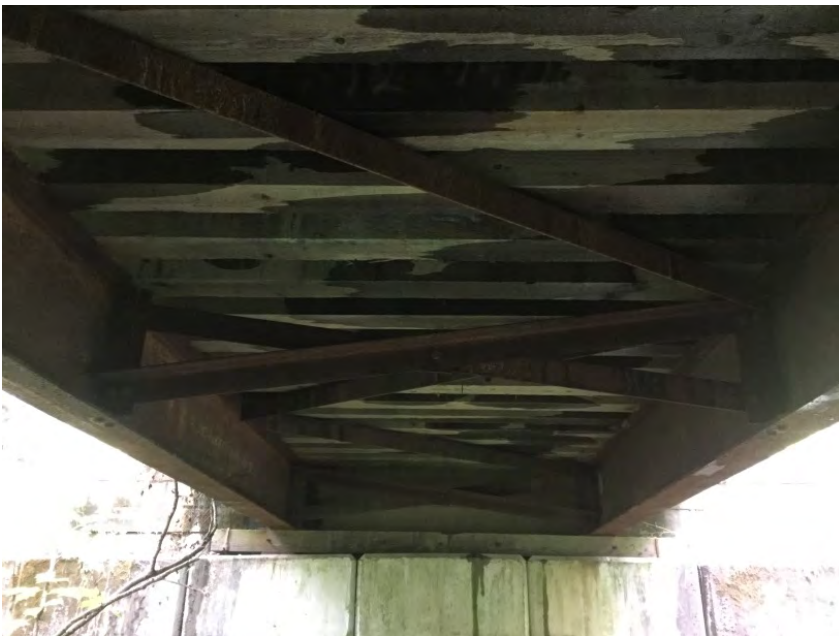
Superstructure

Girders Fair Slight corrosion

Diaphragms Fair 3 bolted bays, slight corrosion

Bracing Fair Slight corrosion
