CK-2022

CHEHALIS 15.2km

2017 Inspection

Crossing Name Statlu Creek

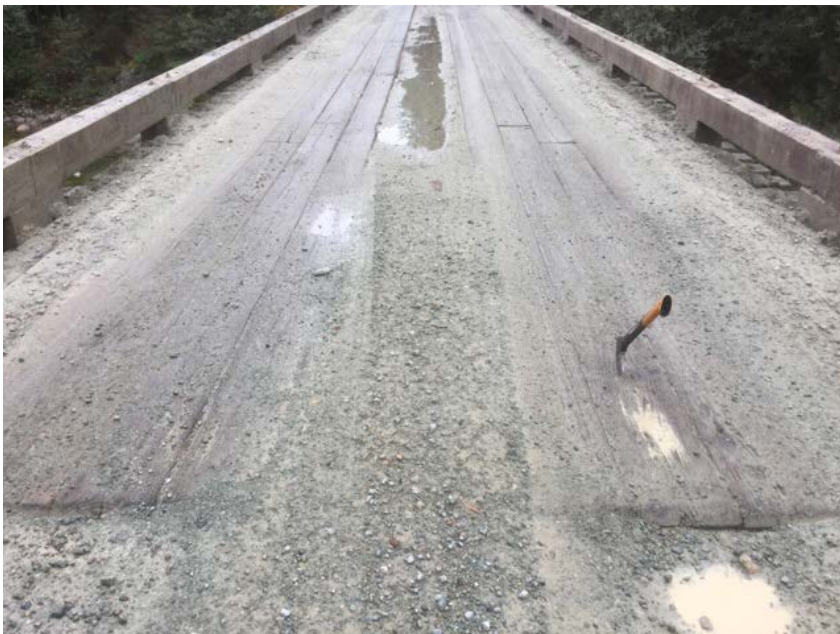
Deck

Subdeck is in poor condition

| 2 | High | Replace ties, subdeck, wear planks, guardrail and risers |

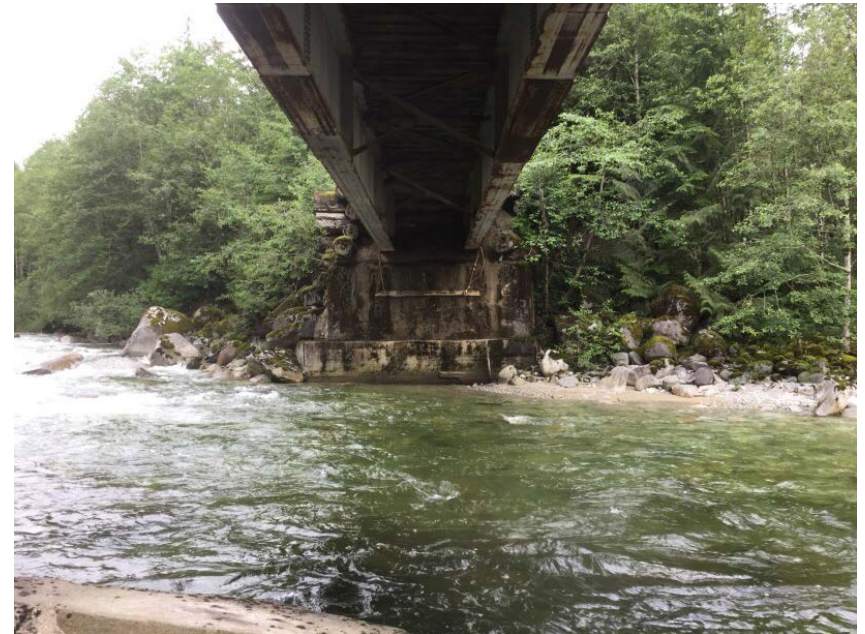
Left Bank Abutment when facing downstream

The left bank abutment cast-in-place concrete is still in fair condition; however there is scour noted under the front face and at the upstream end - this needs to be monitored. The right abutment was replaced in 2007 and is generally in fair condition; however a crack was evident on a bottom row lock block - this needs to be monitored. The end bracing on the steel girders at both abutments are in poor condition with heavy corrosion noted. The timber deck assembly was last replaced in late 2006 and is now in poor condition, especially the subdeck. Due to the poor condition of the subdeck limit loading to BCL-625 or 64 tonnes and plan to replace the entire deck assembly ASAP. While the deck is off replace both end bracing sets (at either abutment) and consider adding riprap to the upstream left abutment. If industrial users are planning to use the bridge prior to replacing the deck assembly and end bracing sets then they must implement an inspection program while in use to ensure the deck assembly is not further degrading; and those inspections must be submitted to the Chilliwack Forest District. If the deck assembly is determined to be further degraded the hauling must be stopped and the entire deck assembly replaced immediately. Contact the Chilliwack Forest District with the planned inspection program prior to use. Due to the age and condition of the abutments the above mentioned works would be considered temporary. For permanent repair options please contact the undersigned.

| Item | Monitor Description | Frequency |
|---|---|---|
| 1 | left bank abutment condition | Routine Inspection |

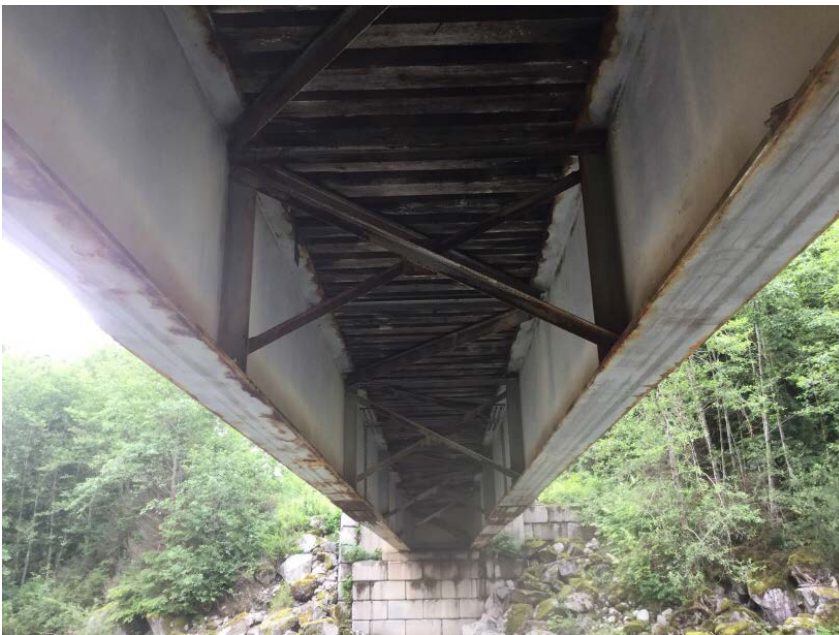
Superstructure

6 welded bays, heavily corroded at bearing locations

| 3 | High | Replace the end bracing sets (both ends) on the girders |
