CK-2068

SLESSE CREEK 6.1km

2017 Inspection

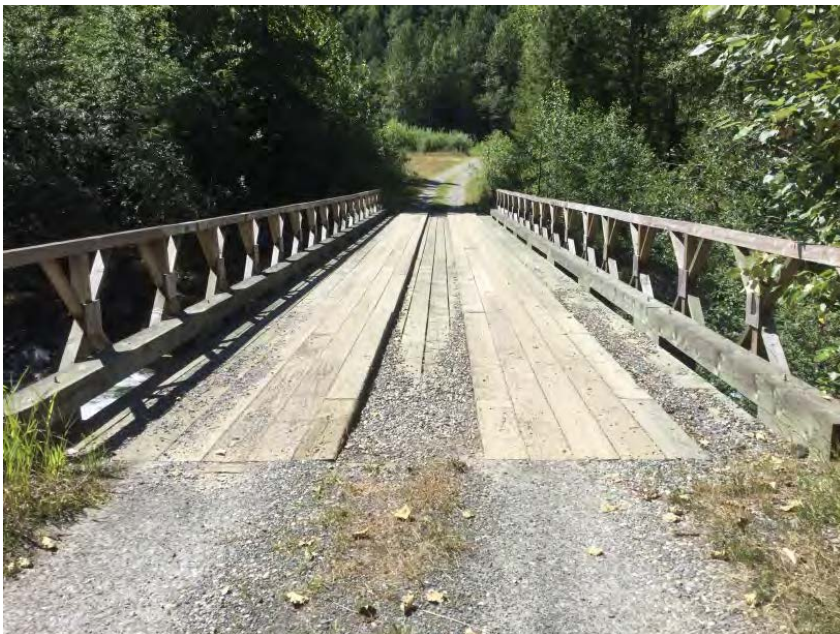
| Overall Deck Condition | Good |

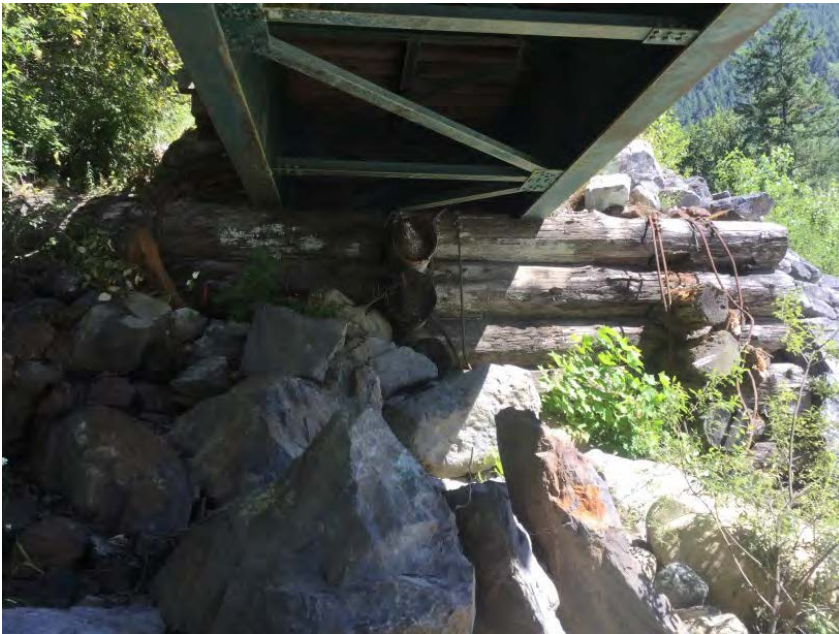
Right Bank Abutment when facing downstream

Log/Timber Cribs Poor 6 face logs (closed - face) both abutments; up to 100mm sap rot; however no crushing apparent

Due to poor condition of the crib the structure is no longer safe for industrial loading. Limit loading to 30 tonnes and plan to replace the entire structure soon. Post load rating sign.
