CK-2519

GARNET EAST 3.5km

2017 Inspection

| Crossing Name | East Fork Garnet Creek |

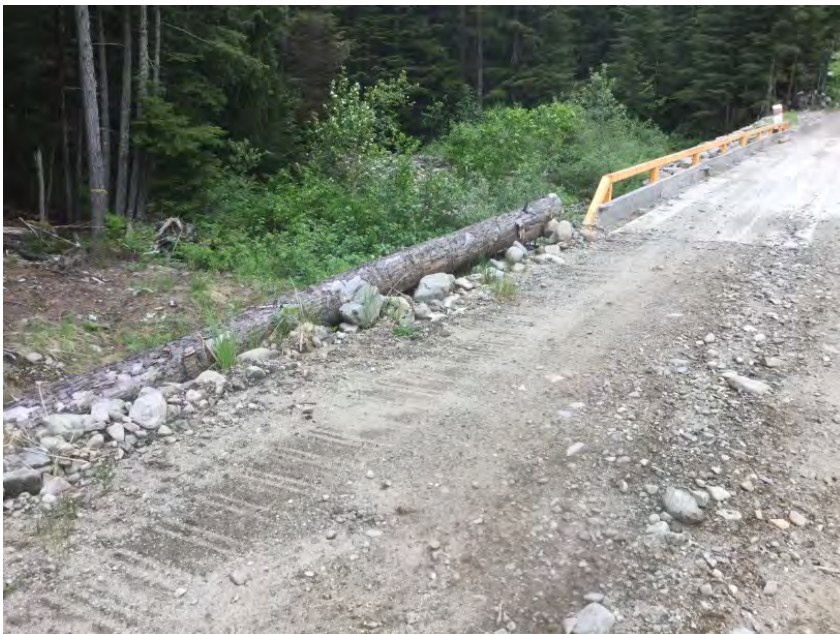
Small fender logs - typical all 4 corners

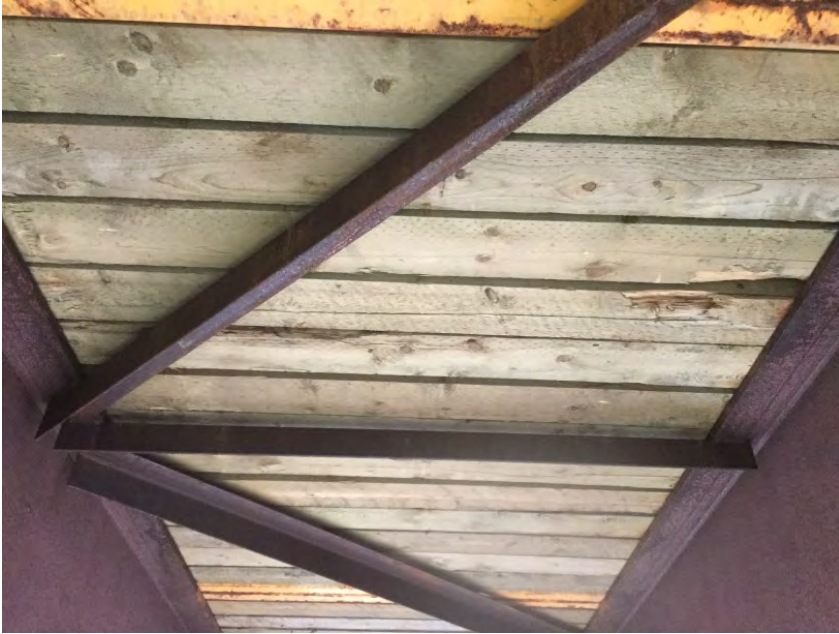
Deck from underneath

Girders Fair Slight corrosion

Diaphragms Fair 6 welded bays, lightly corroded

Bracing Fair Lightly corroded
