CK-2535

PITT RIVER 13.3km

2017 Inspection

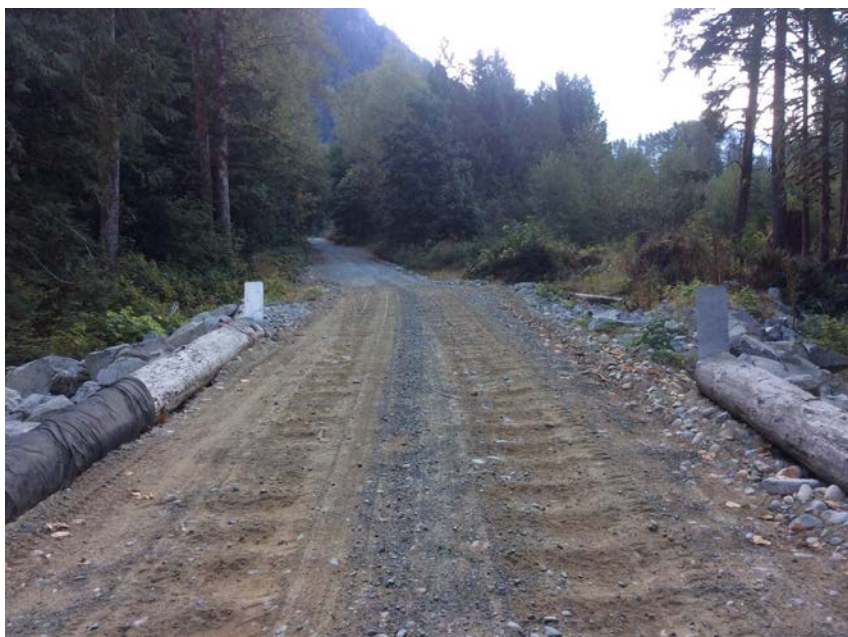
Left approach viewed from bridge

Missing downstream left approach log

| 1 | Low | Replace downstream left approach log. |
