CK-2047

CHEHALIS-MYSTERY 11.9km

2018 Inspection

Crossing Name Mystery Creek

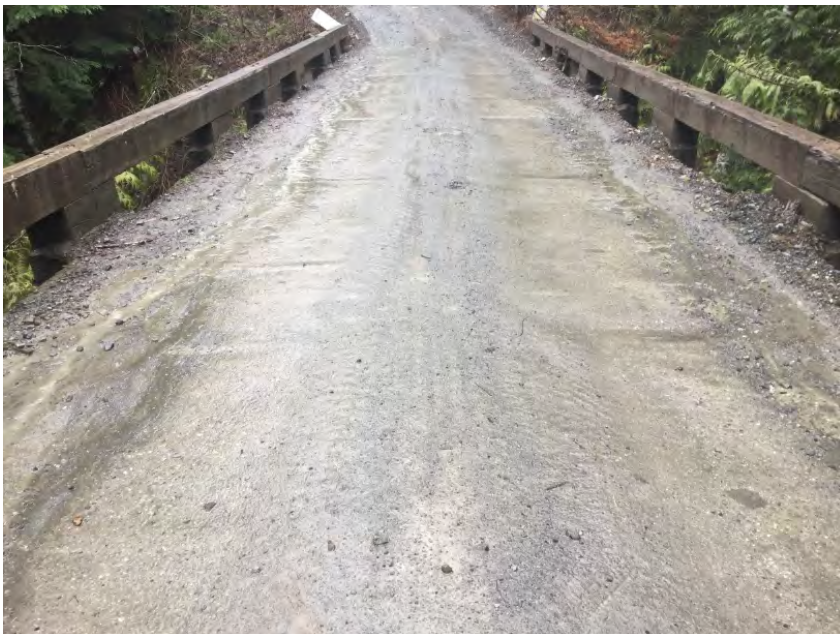
Overall Deck Condition Poor Due to rail condition

| 2 | Medium | Replace guardrail, risers and blocks |

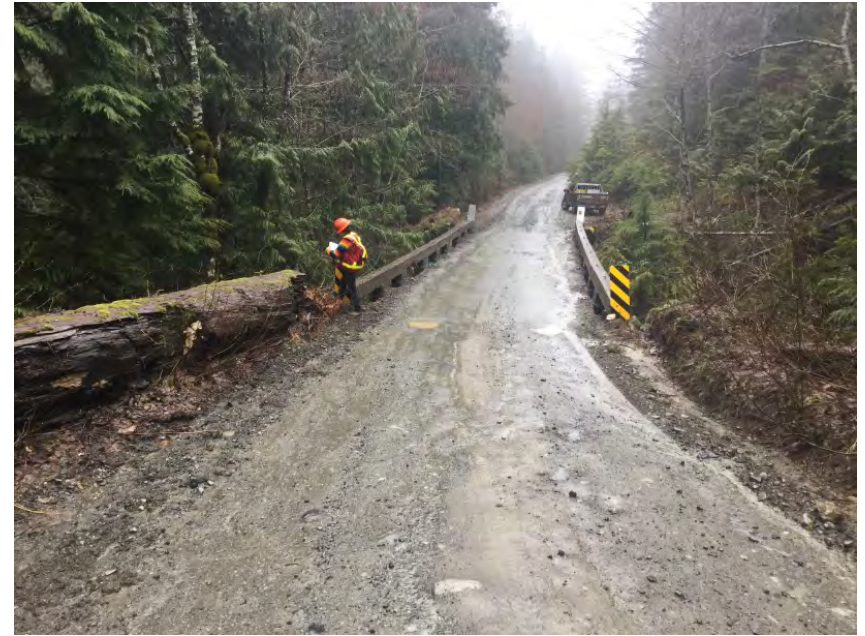
Approach from Left Bank when facing downstream

Delineator Missing Left ☒ 0 ☐ 1 ☐ 2

| Item | Priority | Repair Description |
|---|---|---|
| 1 | Low | Replace 1 right hand delineator at left approach and post bridge ahead signs |
