CK-2072

BENCH 5.2km

2018 Inspection

| Crossing Name | Wells Ranch Creek | | |

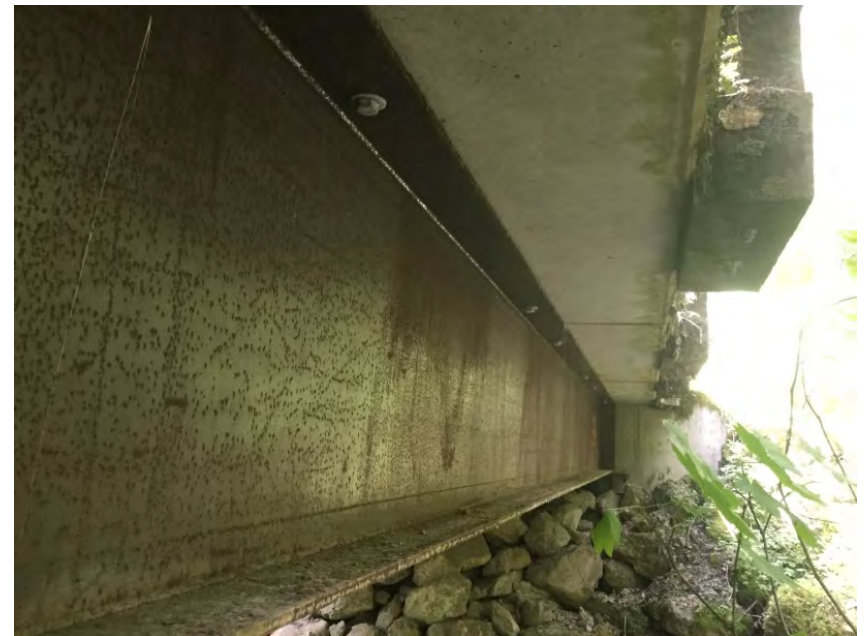
Deck bolts

Hardware Poor Loose rail bolts

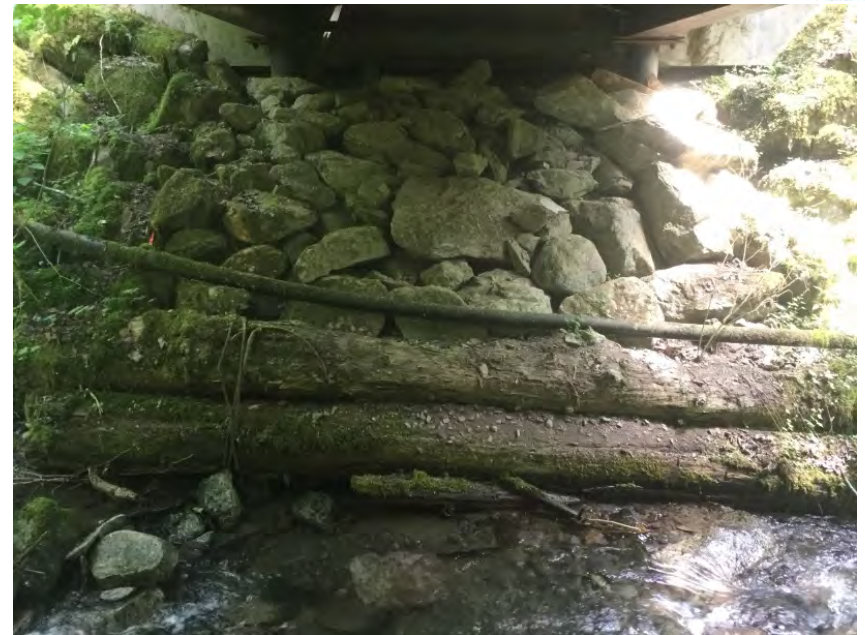
Left Bank Abutment when facing downstream

Ballast Wall Fair Damage noted to top and bottom of left abutment

| Repair Item | Priority | Repair Description |
|---|---|---|
| 2 | Medium | Repair both approach deck panels and left abutment ballast wall |
