CK-2133

STS'AILES (WEST) 18.7km

2018 Inspection

Crossing Name Walian Creek

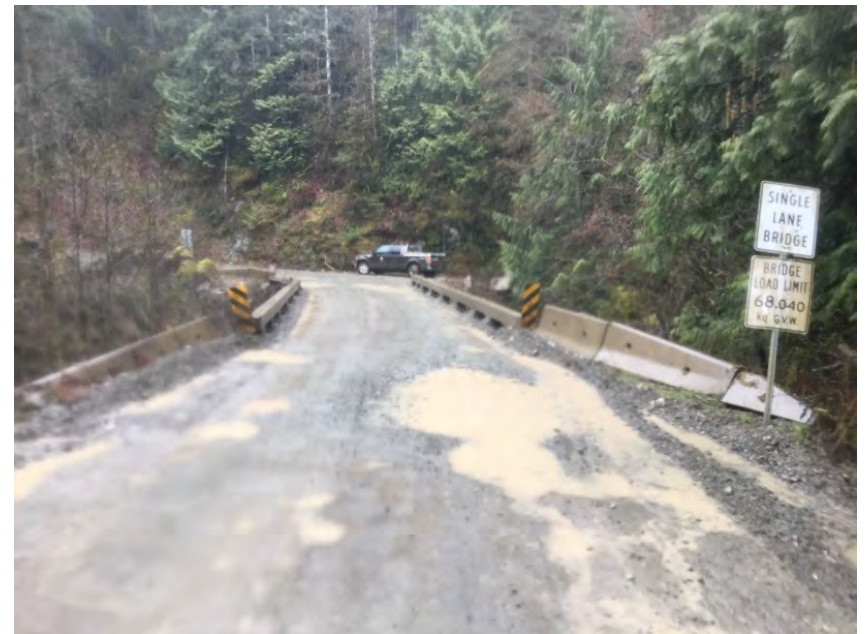
Curb Rail/Blocks/Posts Poor Downstream right approach damaged

Overall Deck Condition Poor Due to damaged guardrail section

Dam aged guardrail

Replace the damaged section of guardrail. Realign the concrete no post barriers at the upstream right approach. Clean the sediment from the deck and grade both approaches. The current load rating of L150 or 136 tonnes to continue.

| Repair Item | Priority | Repair Description |
|---|---|---|
| 1 | High | Replace damaged section of guardrail |
