CK-2175

MURDO 1.2km

2018 Inspection

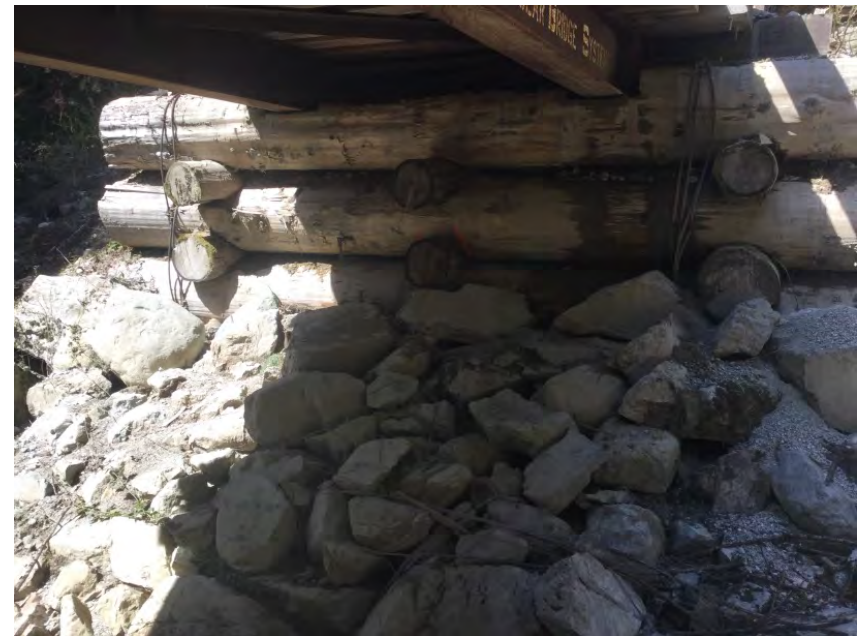
Right Bank Abutment when facing downstream

| Item | Monitor Description | Frequency |
|---|---|---|
| 1 | vertical crack on downstream end of top face log on right bank | Routine Inspection |

Vertical crack in crib log on right bank

Replace both left approach delineators with proper ones. Monitor the vertical crack noted on the downstream end of the top face log on the right bank - no apparent change from last inspection. Present load rating of L60 or 54 tonnes to continue.
