CK-2198

NAHATLATCH 24.9km

2018 Inspection

| Crossing Name | Squakum Creek | | |

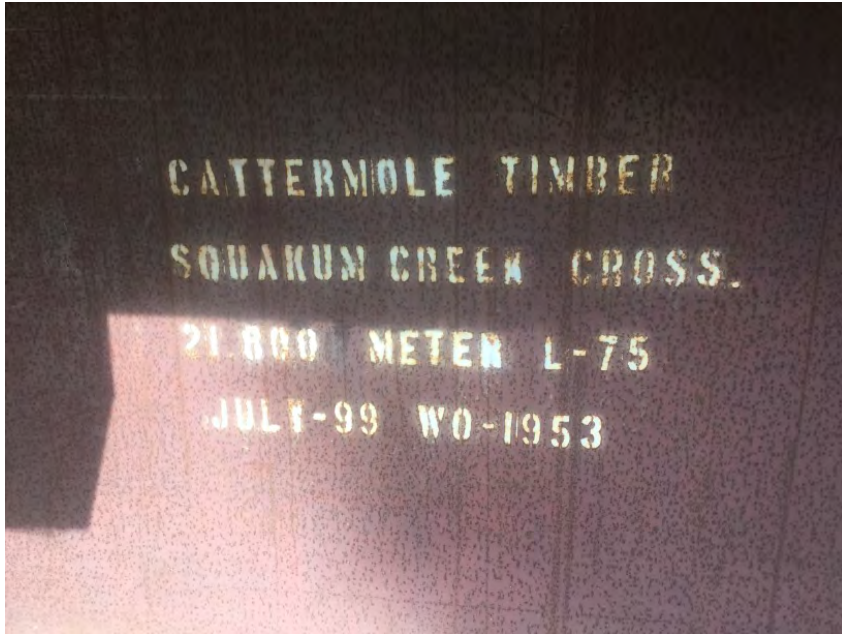
| Item | Monitor Description | Frequency |
|---|---|---|
| 1 | Downstream left bank riprap condition | Routine Inspection |

Downstream left bank riprap steep and rounded

Monitor downstream left bank riprap condition. Present load rating of L75 or 68 tonnes to continue.
