CK-2327

STAVE 0km

2018 Inspection

| Crossing Name | Side Creek | | |

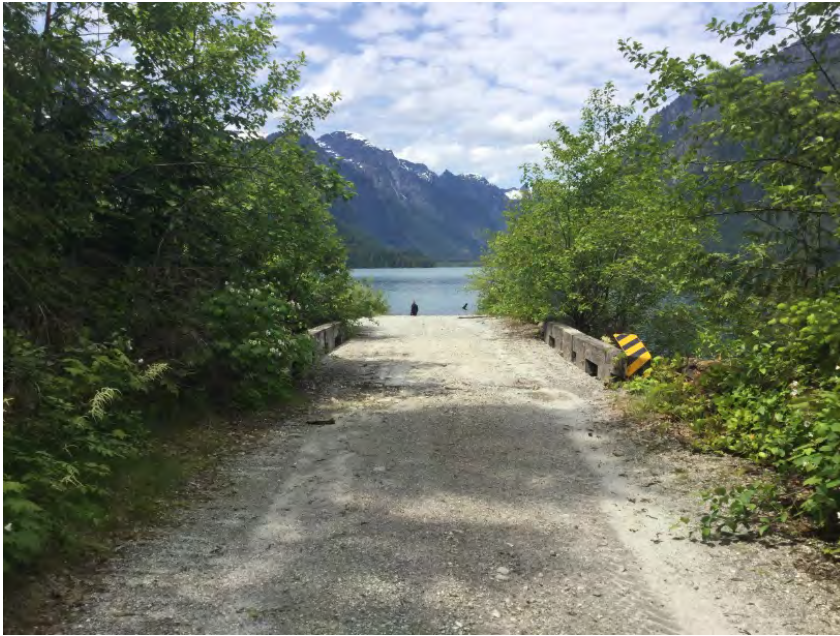
Approach from Right Bank when facing downstream

Fender Condition Poor None at left approach, rotten right approach

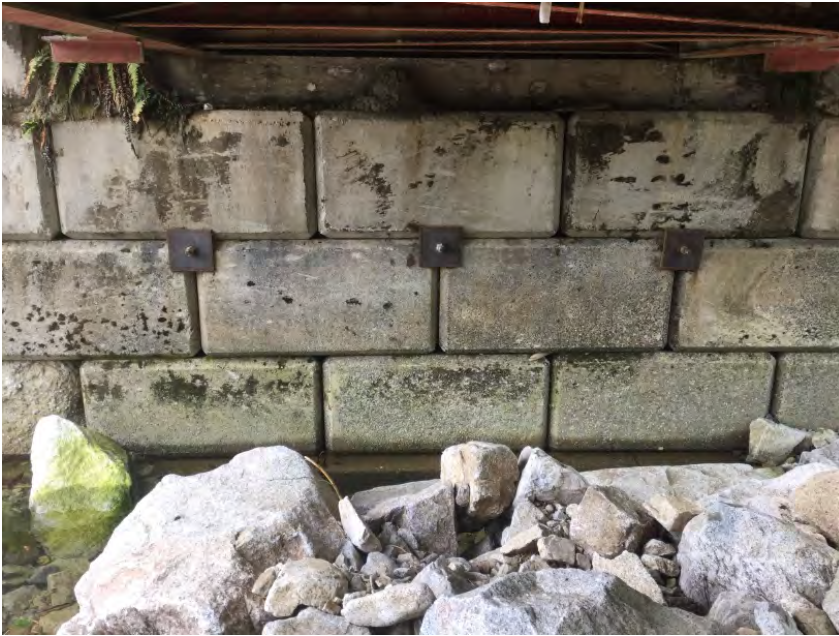
Right Bank Abutment when facing downstream

Concrete Fair 3 rows of lock blocks with D/S right abutment block heavily spalled and now cracked
