CK-2360

KOOKIPI WEST 400 3.8km

2018 Inspection

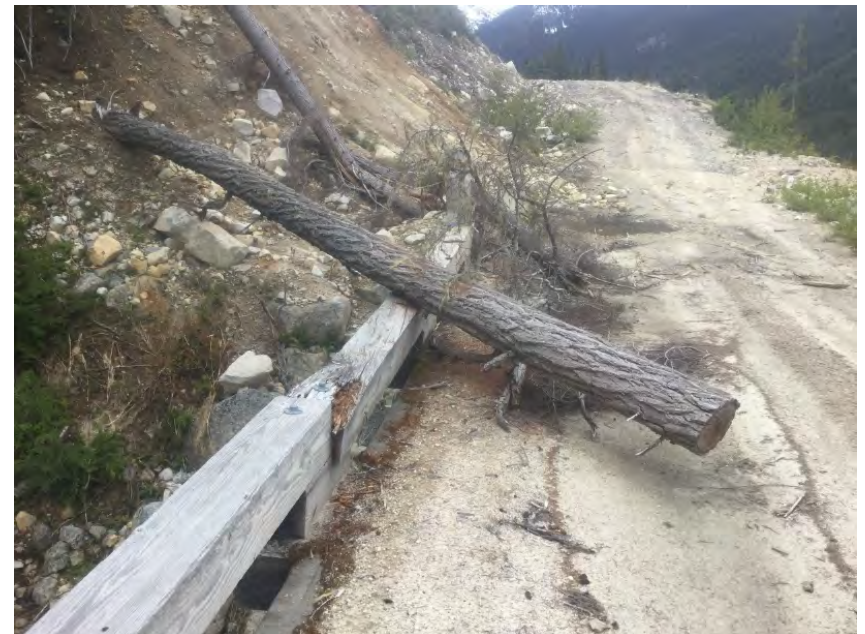
| Overall Deck Condition | Poor | Due to debris on deck and rail condition |

Welded/grouted shear connectors unrated too much sediment on deck to properly inspect but no separation of the beams noted

| Repair Item | Priority | Repair Description |
|---|---|---|
| 1 | High | Replace guardrail, risers and blocks |
