CK-2390

CEDARFLAT 4.6km

2018 Inspection

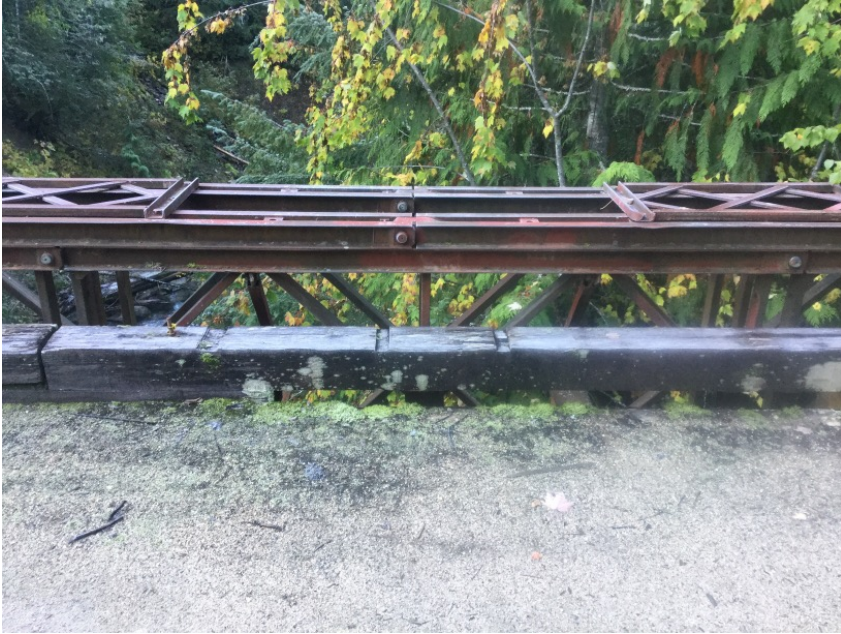
Steel components are aged with damage to some of the bracing frames and end posts.

Diaphragms Poor Rusting

Bracing Poor Rusting

Superstructure condition
