CK-2443

NORRISH CREEK 11km

2018 Inspection

| Crossing Name | Hansen Creek | | |

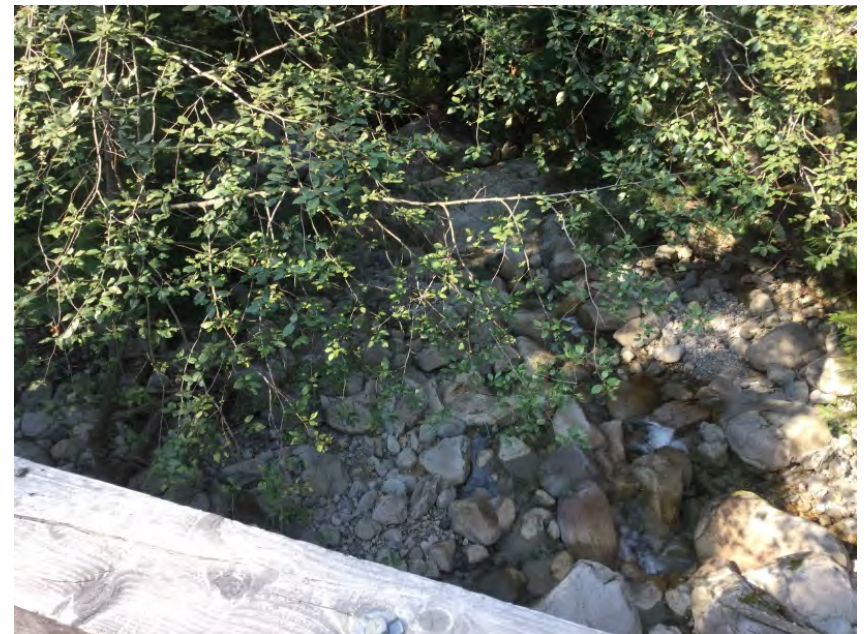
Downstream from Crossing

Riprap Fair small scour noted downstream right bank

Replace guardrail, risers and blocks. Brush approaches and remove the bedload from the inlet of the structure. Monitor the riprap scour noted at the downstream right bank and the bedload accumulations. Current load rating of L100 or 91 tonnes to continue.
