CK-2494

NORRISH 17000 0.1km

2018 Inspection

| Crossing Name | Dickson Creek |

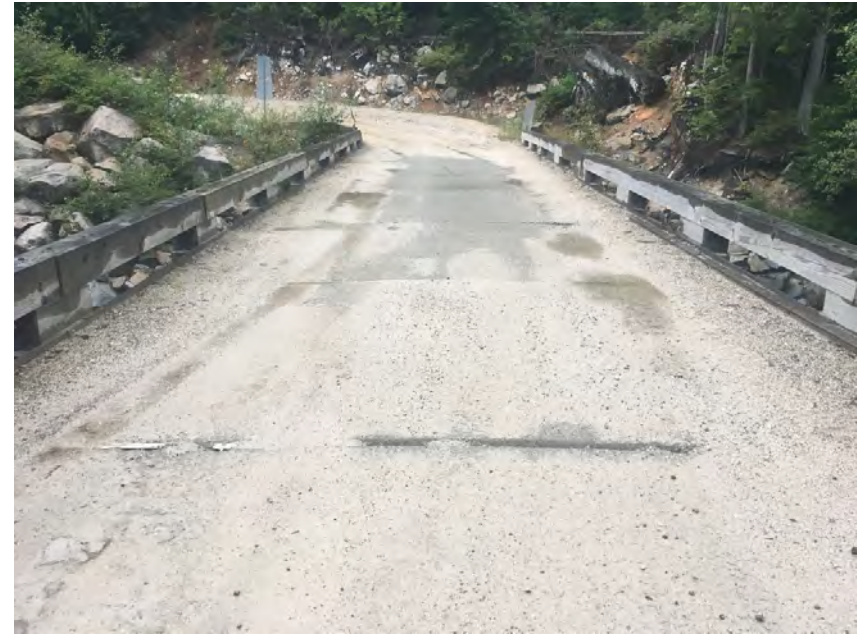
Concrete Deck Fair Damage noted to many of the panel ends

Overall Deck Condition Fair

Repair all damage to deck panels and ballast walls consistent with the Concrete Repair Guide for Concrete Bridge Components (MFLNRO, 2017). Replace all deck seals. Current load rating of L75 or 68 tonnes can continue.
