CK-2508

WINSLOW km

2018 Inspection

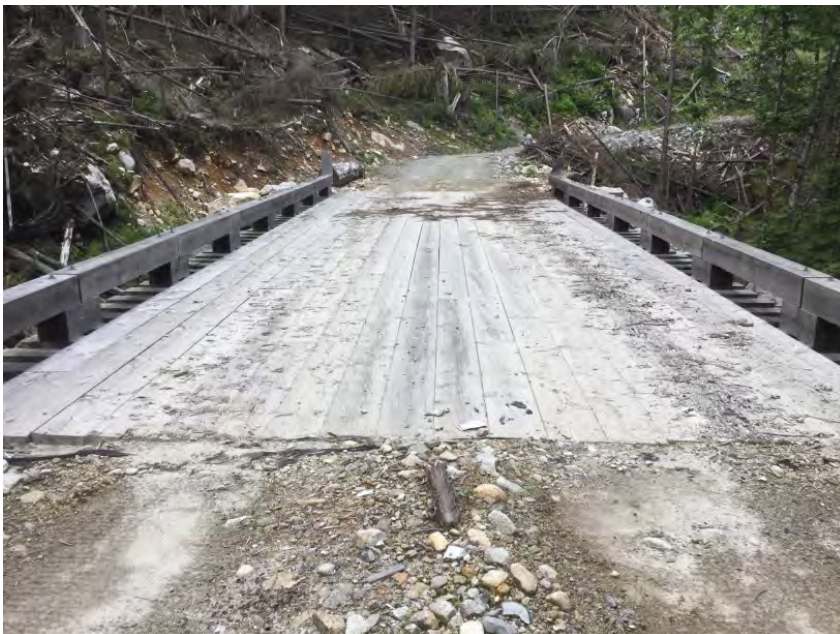
Overall Deck Condition      **Good**

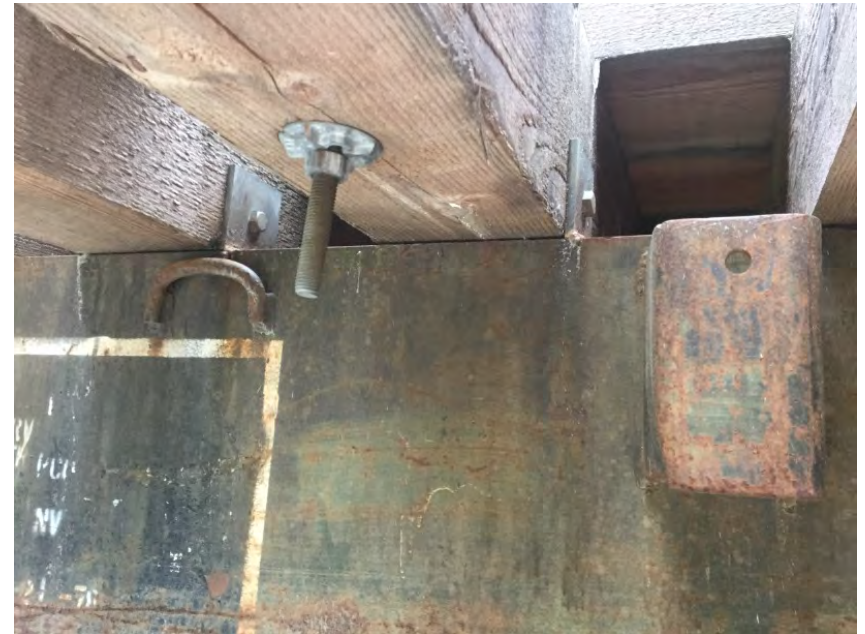
Wooden shims

Monitor shim condition

| Item | Monitor Description | Frequency |
|---|---|---|
| 1 | Shim condition - bearing | Routine Inspection |
